**Bridge Inspection and Assessment –
E&N Railway, Vancouver Island, BC Canada**

**Phase 1 - Inspection Report
Bridges from Mile 1.30 to Mile 65.10 and 2
Bridges on the Wellcox Spur (28 Bridges)**

February 15, 2012

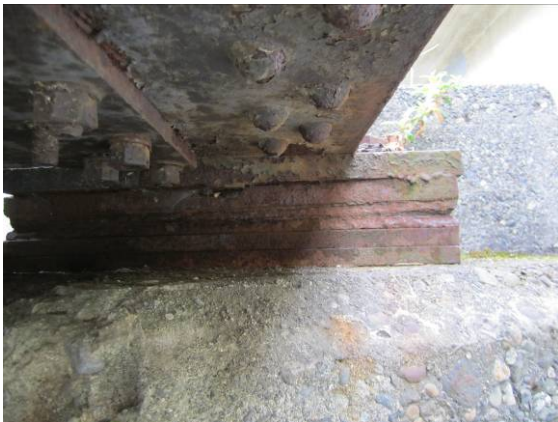
- Vegetation located on abutment seats
- Front edge of abutment seat is spalling under bearings (see attached photo)
- Some minor cracking throughout abutment face
- Bridge is on a skew and abutment ties are bearing on steel girders on one side and the extended abutment backwall on the other side

Concrete Spalling beneath Bearings

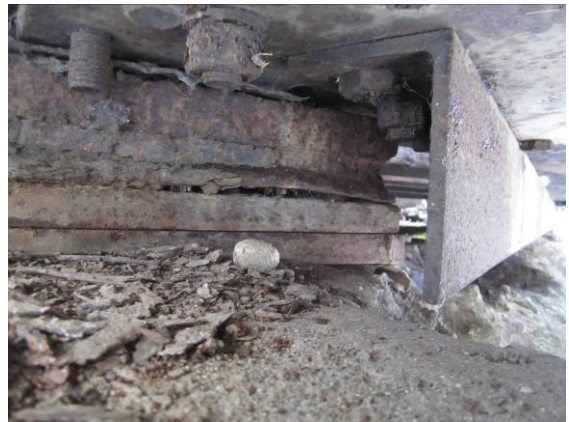
- Steel bearing plates
- Surface corrosion on all bearings; SE bearing plate has pack rust causing the plate to bend
- Other bearing plates have gap between plates
- Anchor bolts are in poor condition; missing nut (see attached photo)

Bearing Corrosion (Typical)

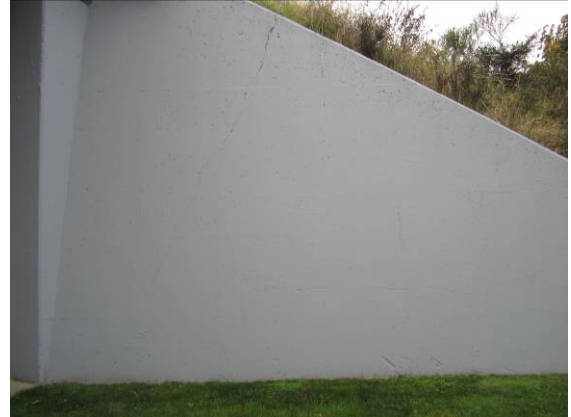
- Large diagonal crack in NE wingwall (see attached photo)
- Minor cracking throughout all wingwalls

Diagonal Crack in NE Wingwall

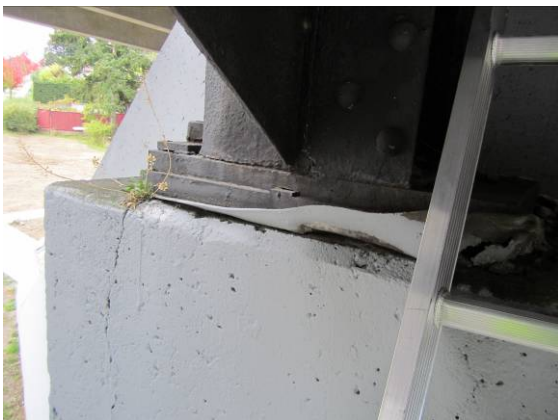
- Small crack under both bearings at north abutment (see attached photo)
- No vegetation or debris located on bearings
- Abutments recently painted

Crack under NW Bearing Plates

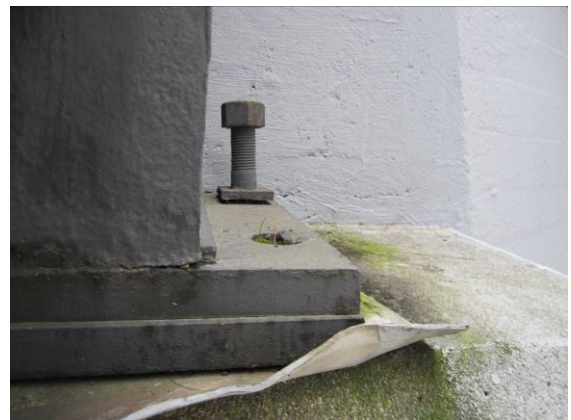
- Steel bearing plates
- Minor surface corrosion
- One anchor bolt missing from both of south abutment bearings (see attached photo)

Missing Anchor Bolt at SW Bearing

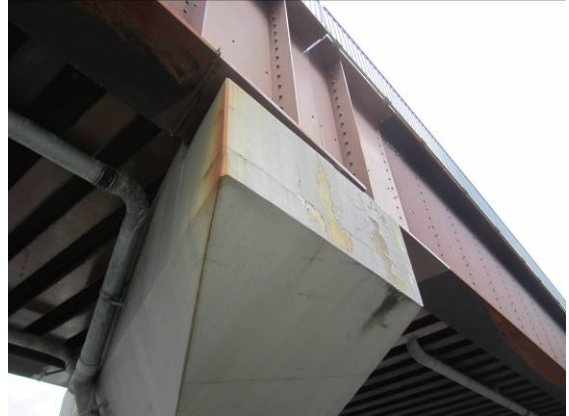
- West side of cap exhibits map cracking (see attached photo)

Map Cracking on Pier 2 Cap

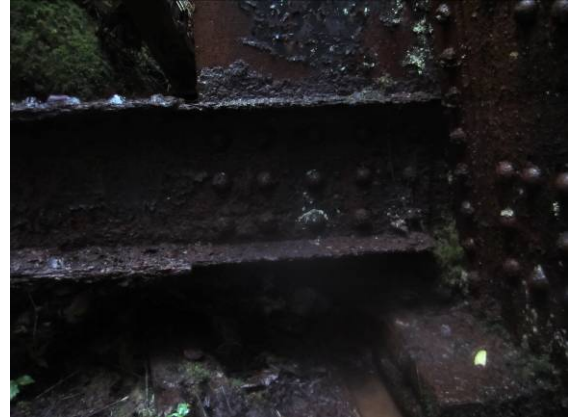
Heavy Corrosion of Steel bottom of Pier 2

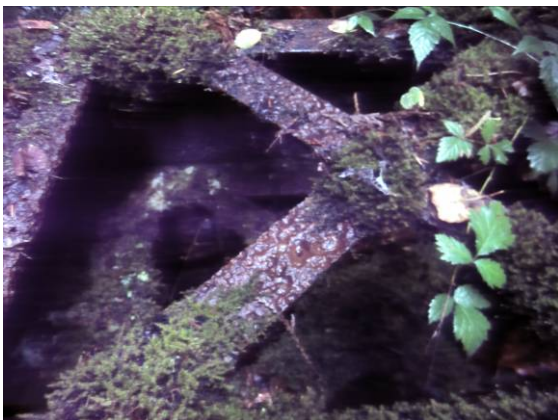
Pier Tower Bottom Lateral Lattice Corrosion

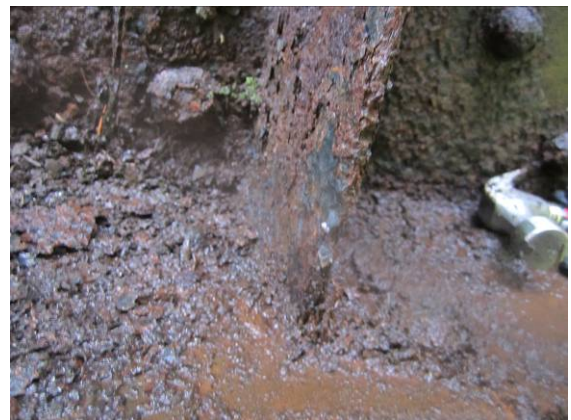
Stiffener Section Loss near Bottom Flange

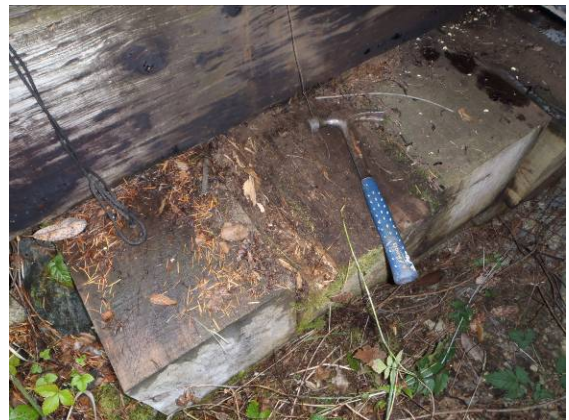
Rot in North Abutment Bent

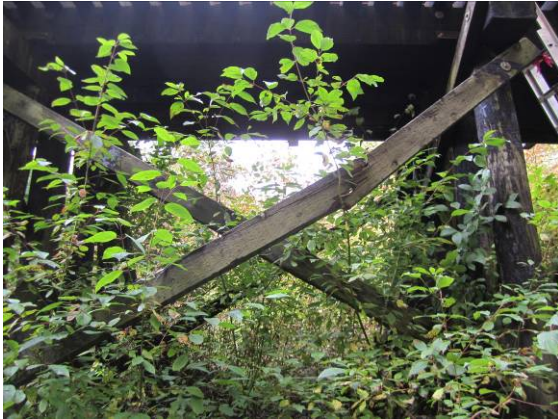
Broken Diagonal Member at Span 4 (East)

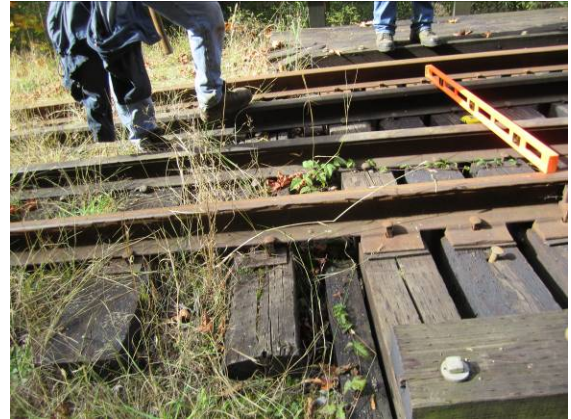
Low South Approach

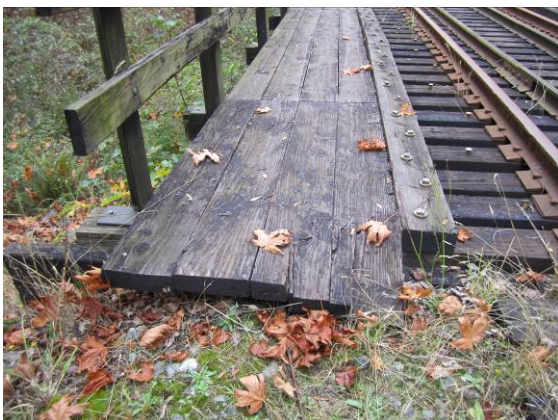
Broken Walkway Boards (South End)

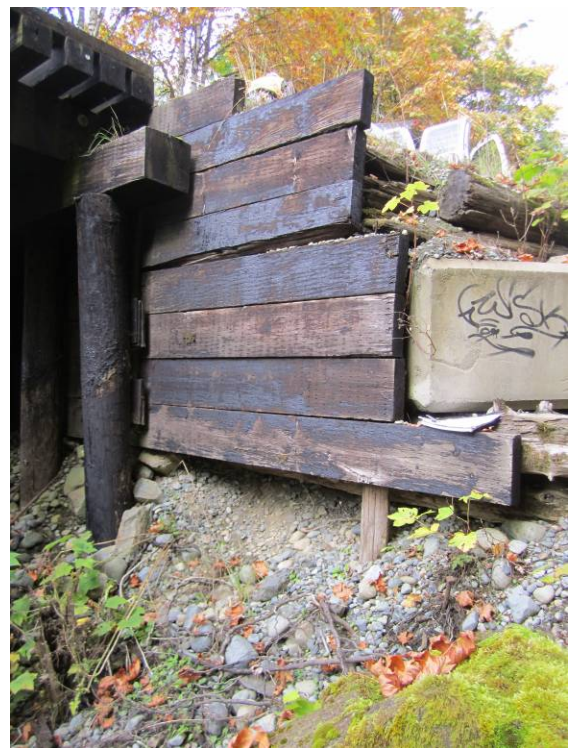
Erosion at North End Bent (East Side)

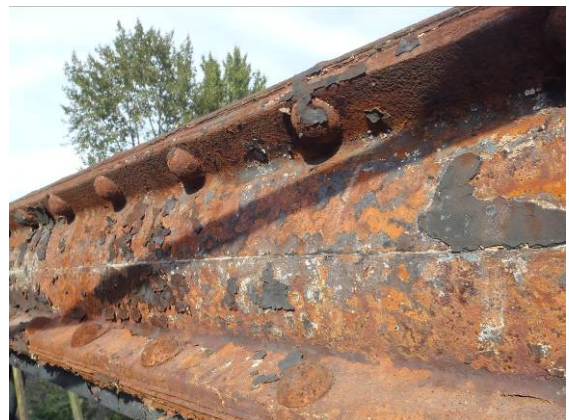
Groove in Top Chord Member (Typical)

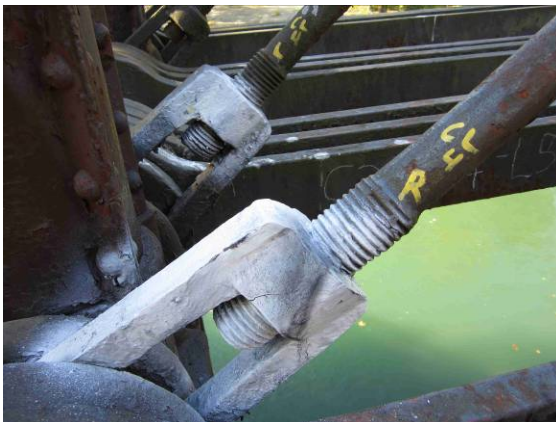
Crack in Turnbuckle Nut of Diagonal

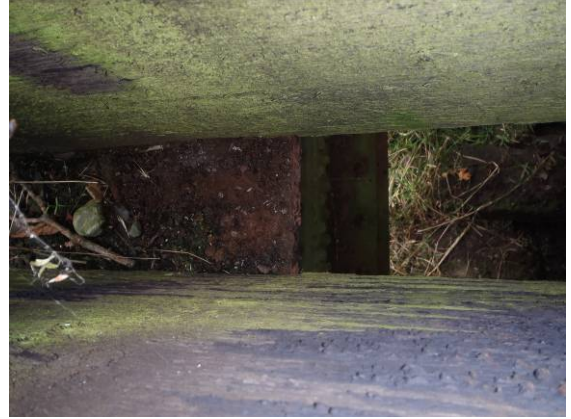
View of Corroded Top Flange from Above

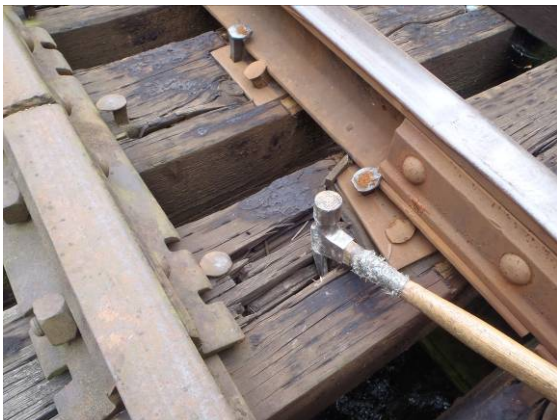
Poor Tie Condition

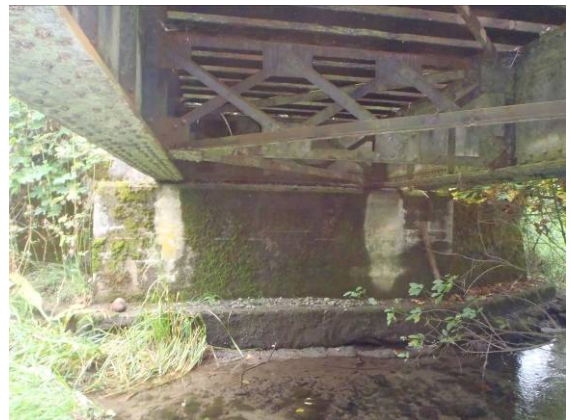
Undermining of North Abutment Footing

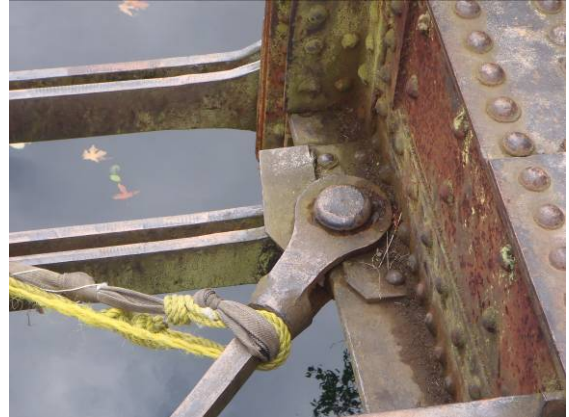
Plate Failure at Bottom Lateral Bracing (L2R)

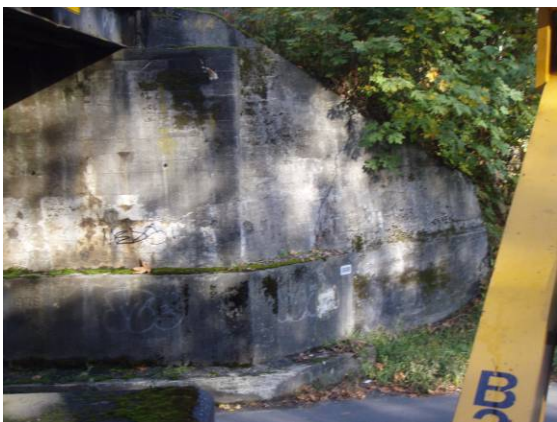
Diagonal Crack in East Wingwall (North Abutment)

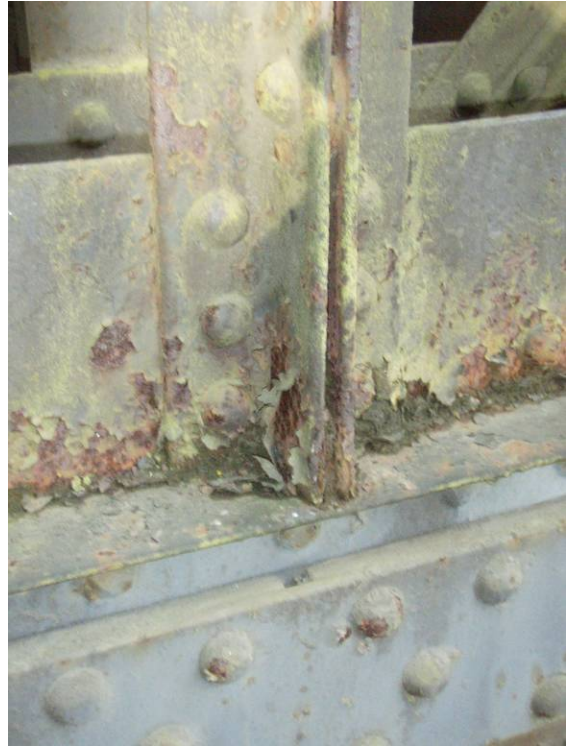
Pack Rust between Vertical Post Angles

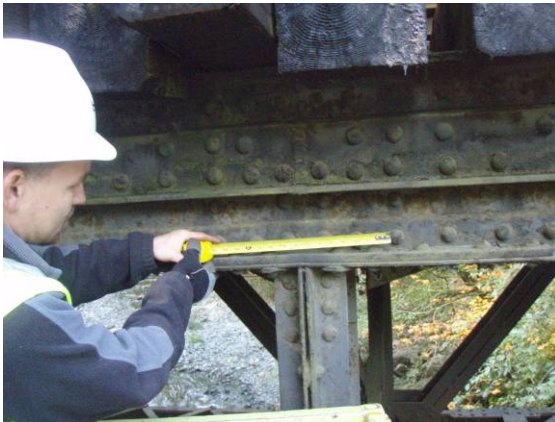
Top Chord Flange Bent at Midspan Post

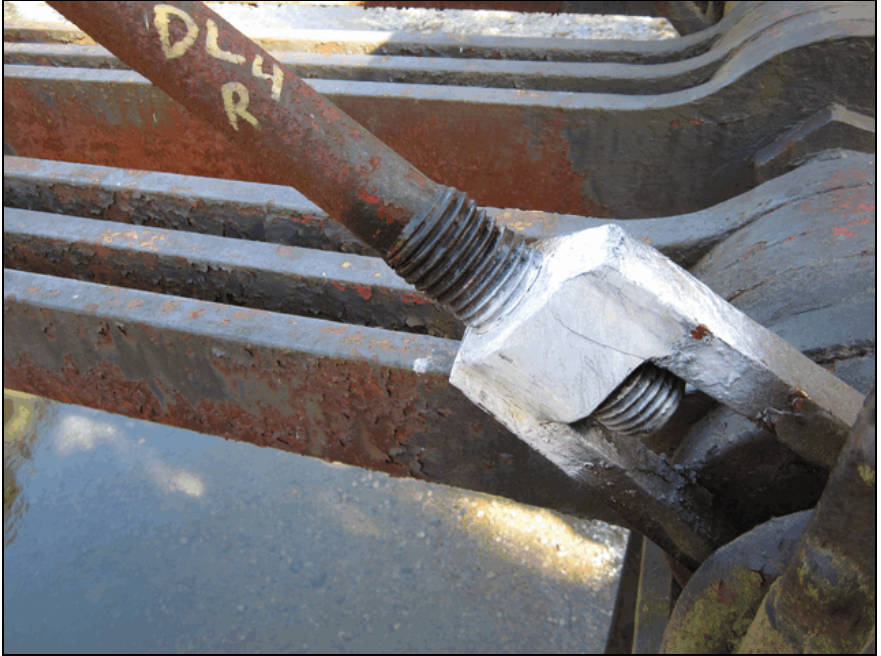
Photo 10:

Close up showing the crack indication on one side of the collar of turnbuckle D-L-4-Right

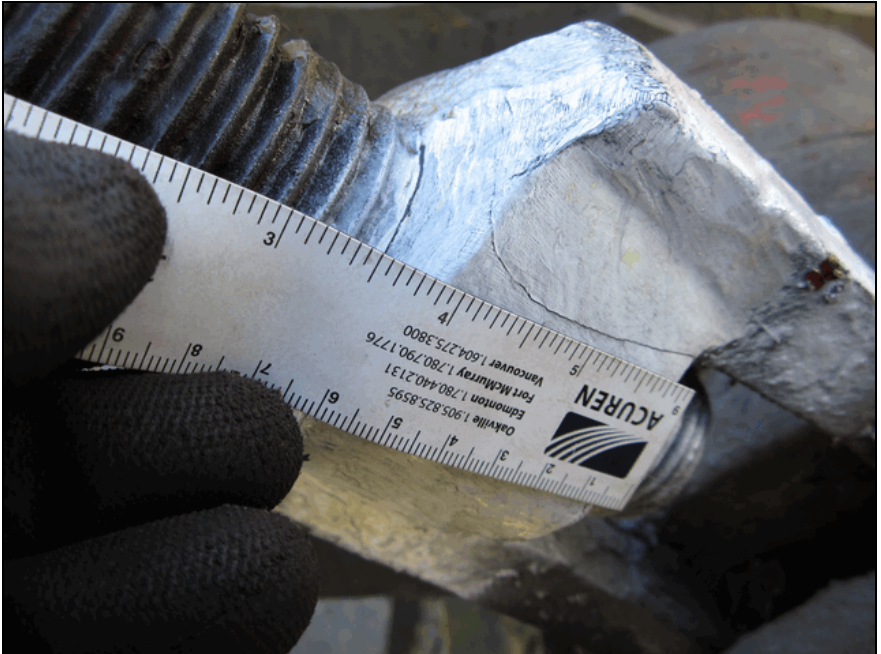
Photo 11:

Overview of cracking on D-L-5-Left.

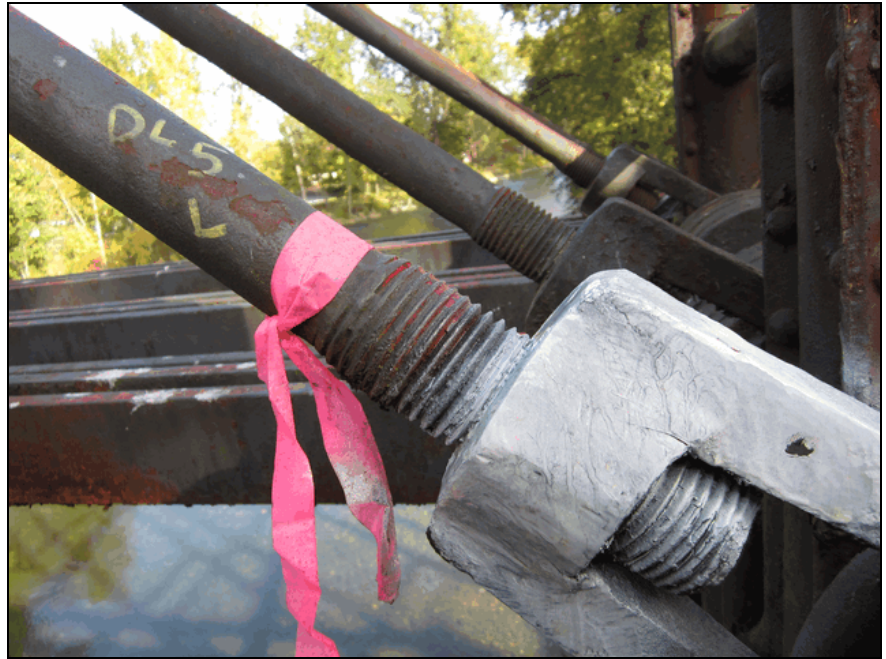
Photo 12:

Close up of D-L-5-Left showing an intermittent crack indication.

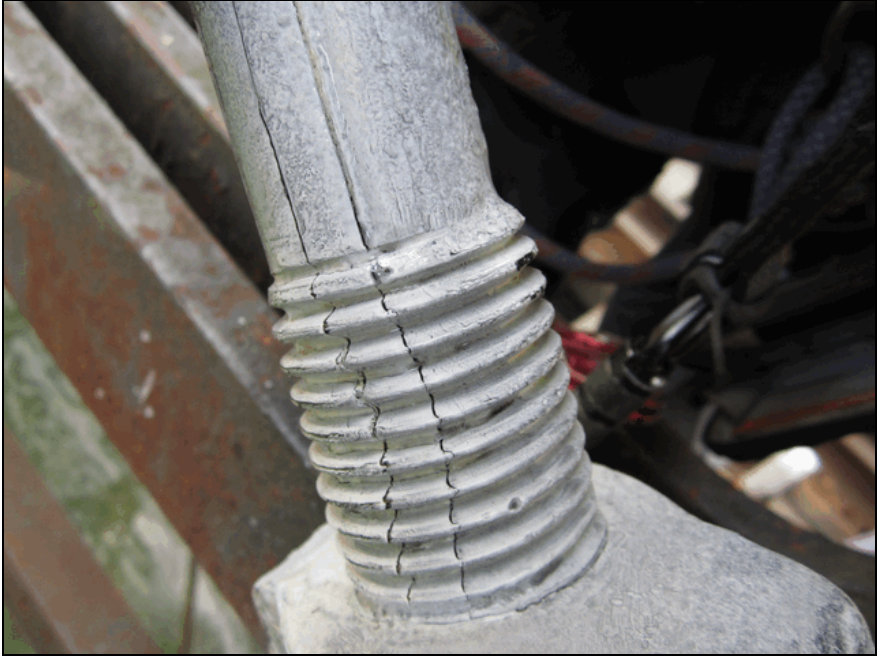
Photo 14:

Crack indications noted on CL4- Right. On the underside

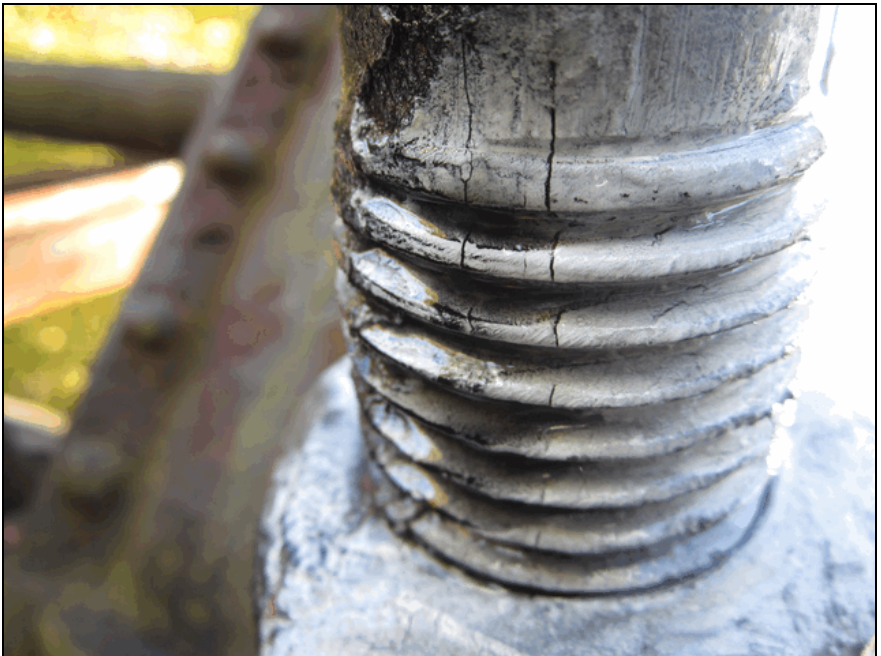
Photo 15:

Crack indications noted in the threads on DL4-Left side.

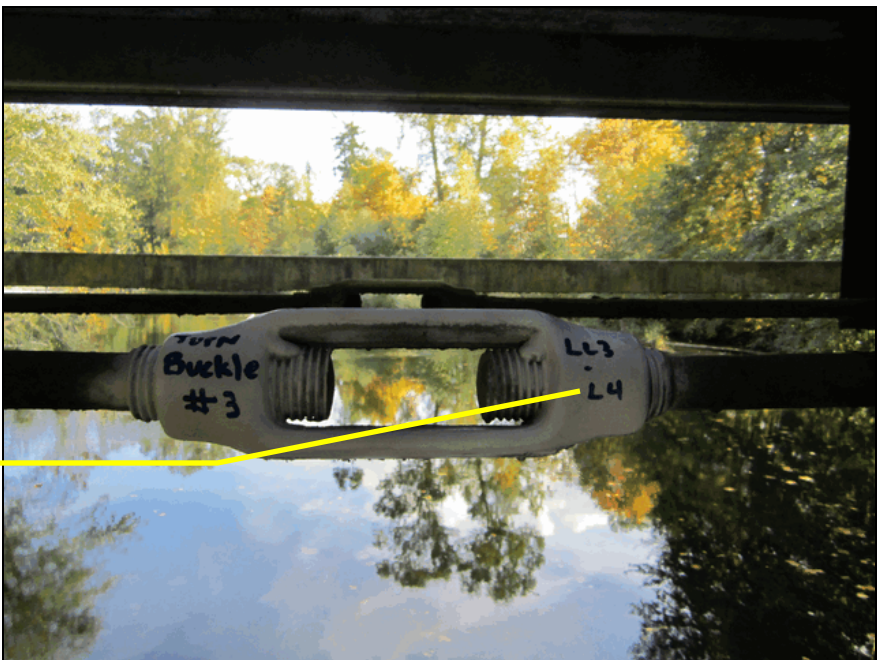
Photo 5:

3" crack
indication
found here

Close up of 3" crack found on Turnbuckle Lower 3 to Lower 4 on Queen Post Truss #3.

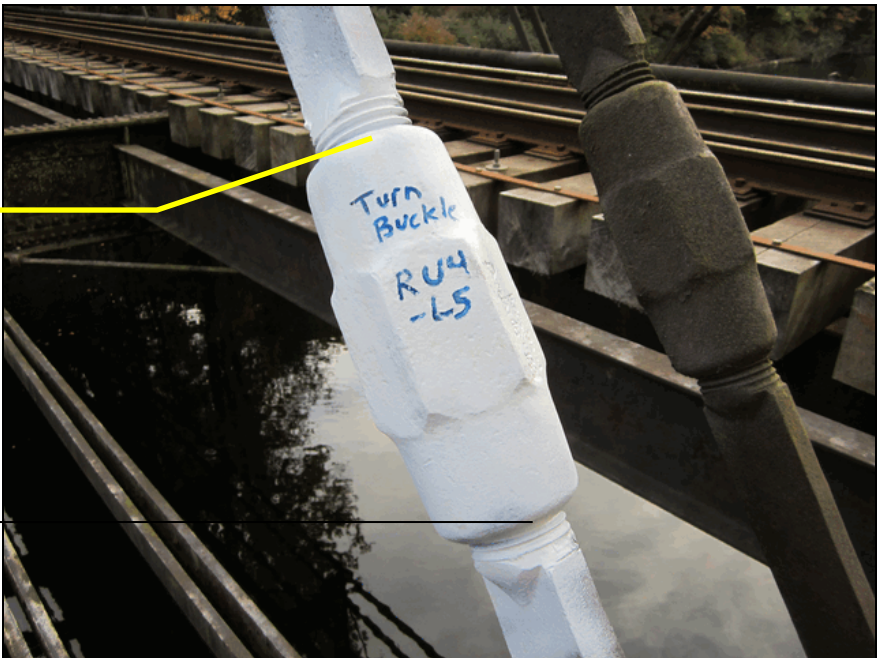
Photo 7:

1" crack indication noted in the upper portion of the turnbuckle on the diagonal at Right Upper 4 to Lower 5.

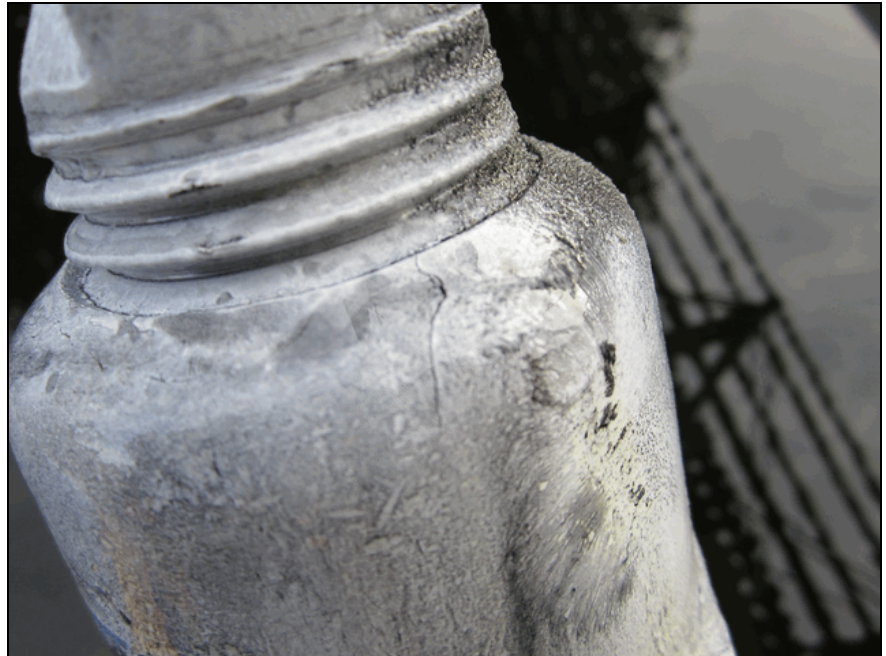
Photo 8:

Two (2) crack indications, approximately 1" each, noted in the lower portion of the turnbuckle and in the threads on the diagonal at Right Upper 4 to Lower 5.
