Ministry of Transportation and Infrastructure

Bridge Inspection and Assessment – E&N Railway, Vancouver Island, BC Canada

Phase 3 - Inspection Report Bridges from Mile 79.10 to Mile 135.10 (20 Bridges)

February 15, 2012

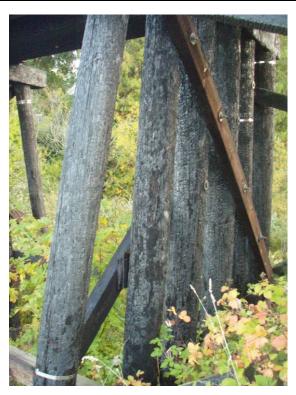
Intermediate Pile Bent Fire Damage (Typical)

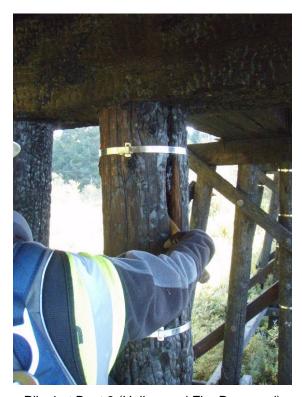
Pile 4 at Bent 9 (Hollow and Fire Damaged)

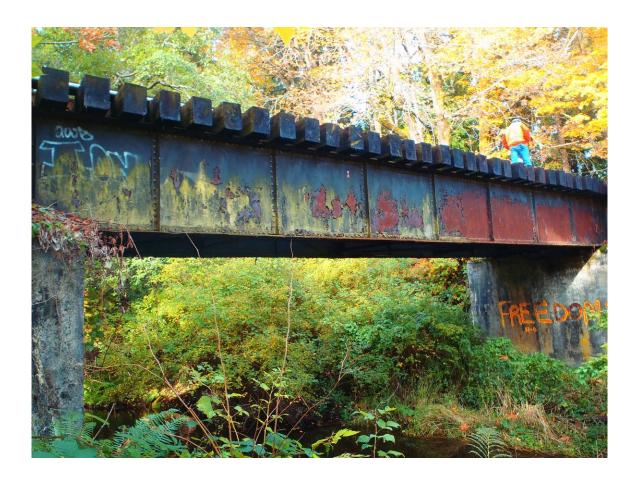
Corrosion of Bottom Flange Angle (Typical)

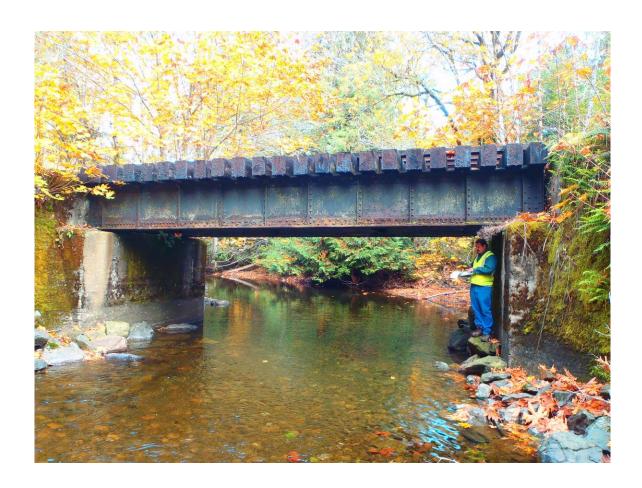
Corrosion of Bottom Flange Angle (Typical)

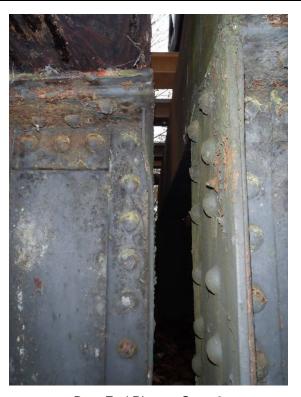
Bent End Plate at Span 3

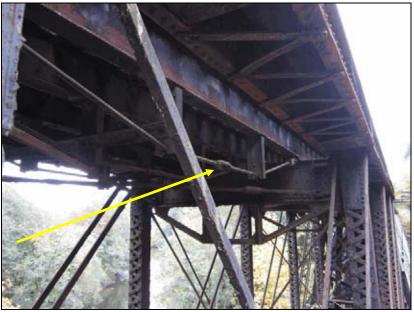
Photo 2:

Overview of the Queen Post Truss.

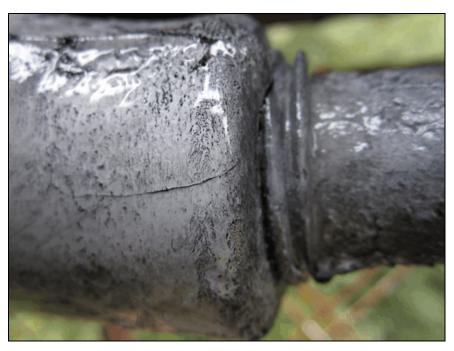
Photo 6:

Overview of the end of eyebar #1 (outside) running from LL4 to LL3 showing the location of the inherent defects noted visually and confirmed with MPI.

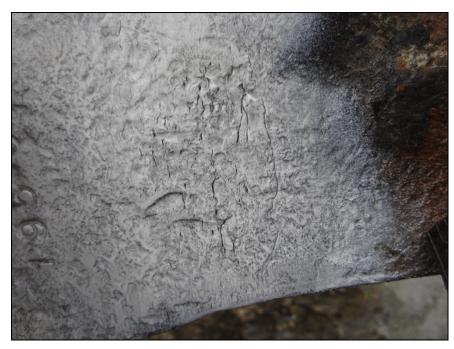
Photo 8:

Original manufacturing defects noted at bottom of eyebar. This pattern could be seen visually before magnetic particle test was performed. Appears to be shrinkage cracks.

This bar in behind eyebar not attached to it. See overview in Photo 6.

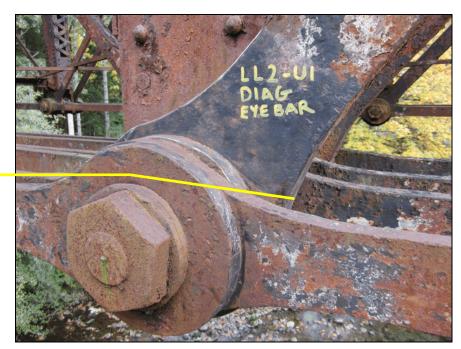
Photo 10:

Markings noted on edge of eyebar located at of Left Lower 2 to Upper 1 Diagonal eyebar. Magnetic Particle testing showed no crack indications coming off of these grooves.

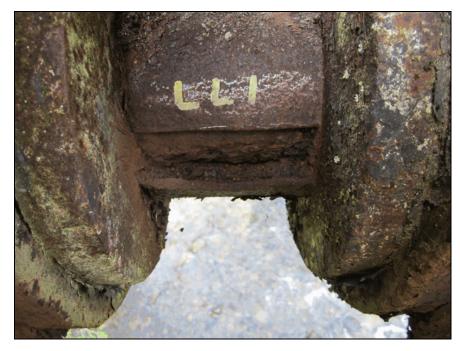
Photo 11:

Opening on sheave at pin Lower Left 1 allowing moisture to corrode pin.

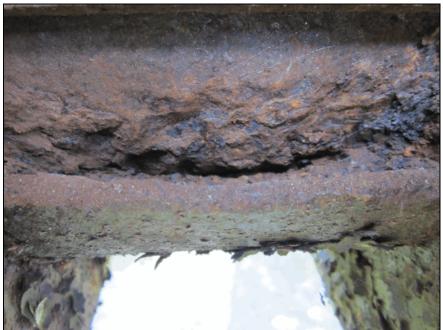
Photo 12:

Corrosion noted on outer surface of pin at Lower Left 1. The corrosion on the side could not be seen with the ultrasonic test from the end of the pin.
