Ministry of Transportation and Infrastructure

Bridge Inspection and Assessment – E&N Railway, Vancouver Island, BC Canada

Phase 3 - Inspection Report Bridges from Mile 79.10 to Mile 135.10 (20 Bridges)

February 15, 2012

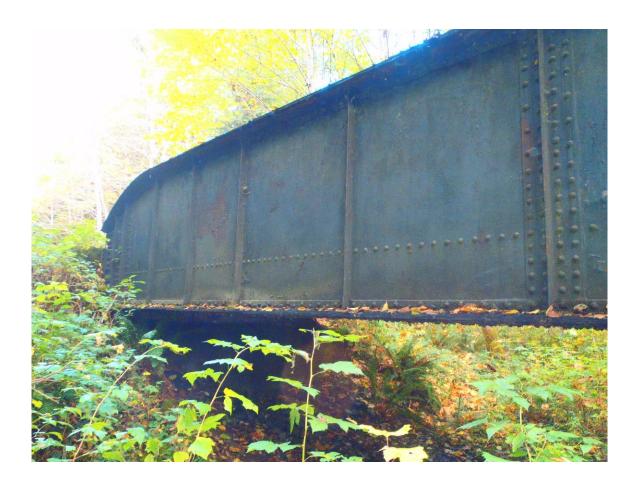
Corroded South Bearing (Typical)

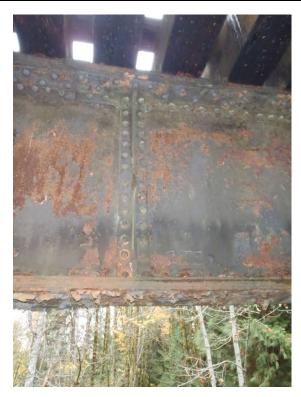
Bent Intermediate Stiffener in Span 2

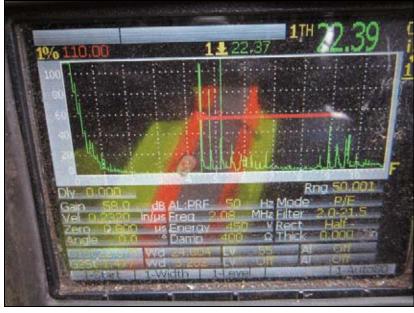
Photo 1:

Screen shot showing typical inspection results. This one from Left side Upper pin number 4.

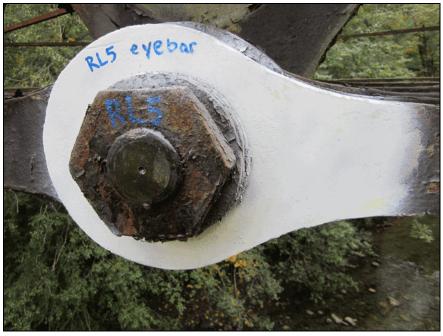
Photo 3:

Testing performed on Right Lower 5 eyebar end. MT Ok.

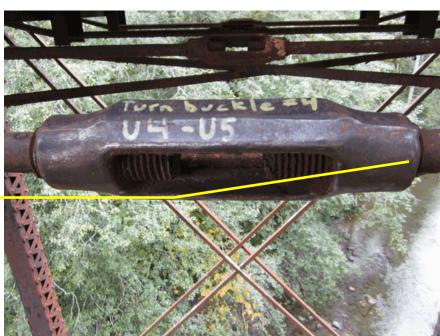
Photo 4:

Overview of turnbuckle #4 on the Queen Post Truss running between Upper 4 and Upper 5.

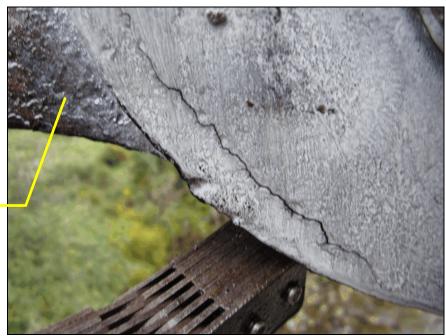
Photo 10:

Markings noted on edge of eyebar located at of Left Lower 2 to Upper 1 Diagonal eyebar. Magnetic Particle testing showed no crack indications coming off of these grooves.

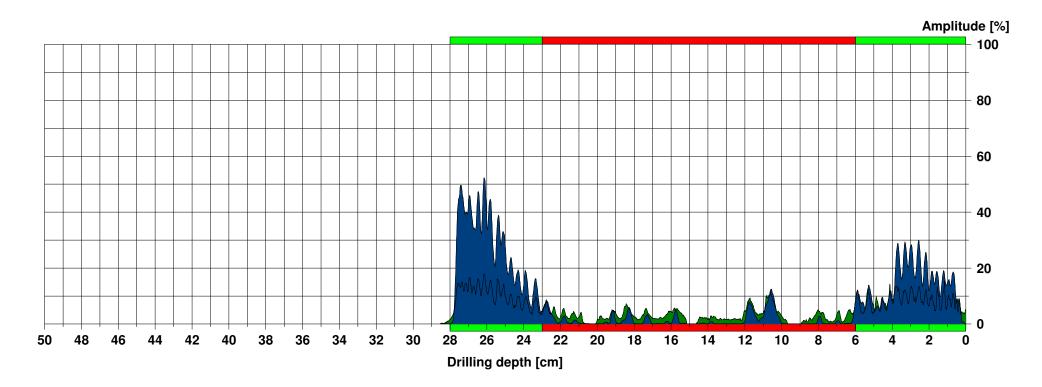
From	0,0 cm	to	6,0 cm : Sound
From	6,0 cm	to	23,0 cm : Rot
From	23,0 cm	to	28,0 cm : Sound
From	0,0 cm	to	0,0 cm :
From	0,0 cm	to	0,0 cm :
From	0,0 cm	to	0,0 cm :

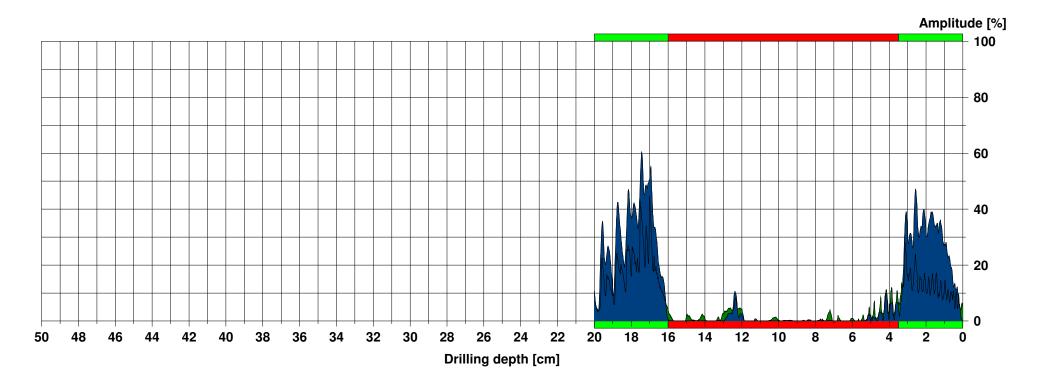
From	0,0 cm	to	3,5 cm : Sound	
From	3,5 cm	to	16,0 cm: Void	
From	16,0 cm	to	20,0 cm: Sound	
From	0,0 cm	to	0,0 cm :	
From	0,0 cm	to	0,0 cm :	
From	0,0 cm	to	0,0 cm :

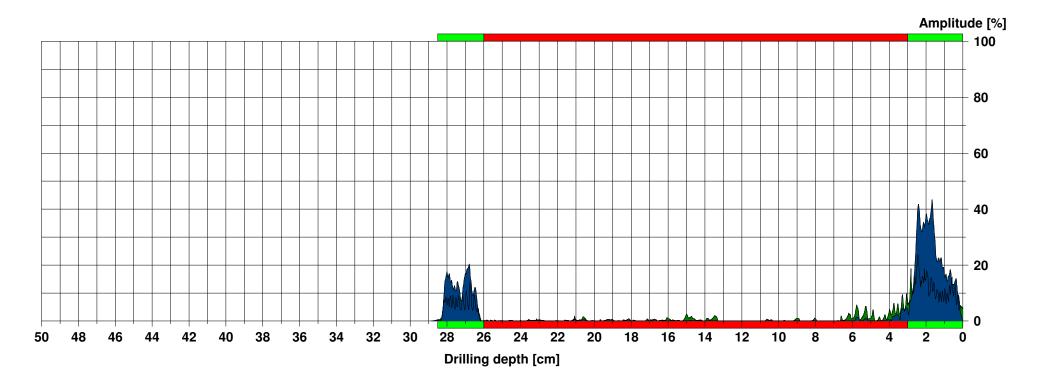
From	0,0 cm	to	3,0 cm : Sound
From	3,0 cm	to	26,0 cm : Void
From	26,0 cm	to	28,5 cm : Sound
From	0,0 cm	to	0,0 cm :
From	0,0 cm	to	0,0 cm :
From	0,0 cm	to	0,0 cm :

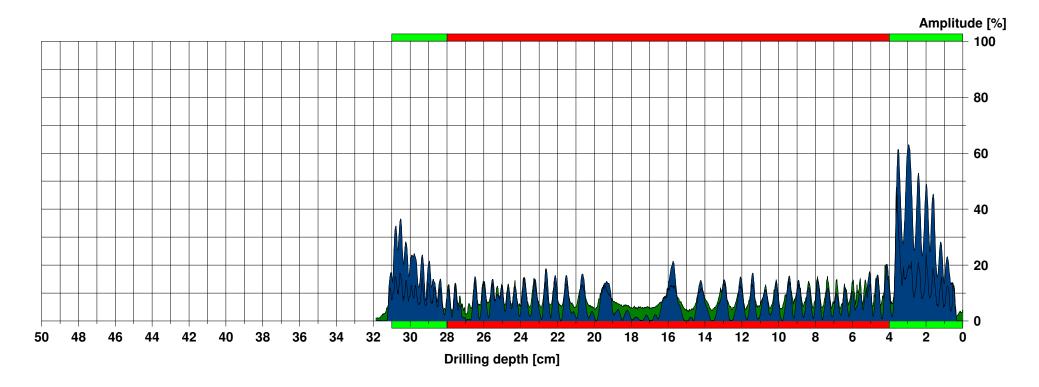
From	0,0 cm	to	4,0 cm: Sound
From	4,0 cm	to	28,0 cm: Partial Rot
From	28,0 cm	to	31,0 cm: Sound
From	0,0 cm	to	0,0 cm :
From	0,0 cm	to	0,0 cm :
From	0,0 cm	to	0,0 cm :
