**Bridge Inspection and Assessment –
E&N Railway, Vancouver Island, BC Canada**

**Phase 1 - Inspection Report
Bridges from Mile 1.30 to Mile 65.10 and 2
Bridges on the Wellcox Spur (28 Bridges)**

February 15, 2012

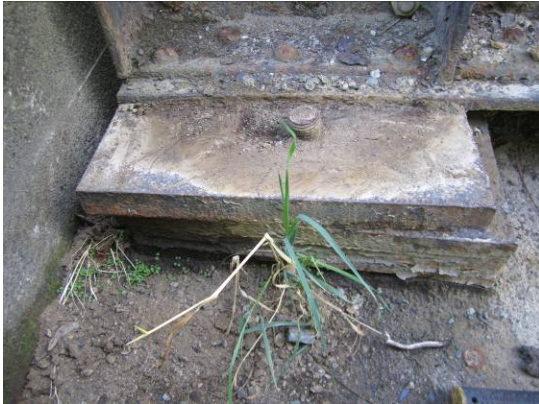
Anchor Bolt without Nut (Typical)

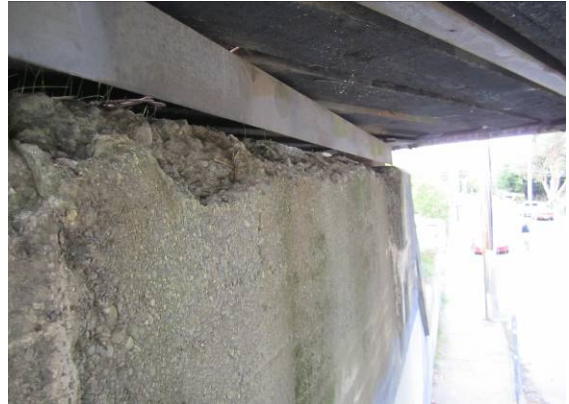
- Vegetation located on abutment seats
- Front edge of abutment seat is spalling under bearings (see attached photo)
- Some minor cracking throughout abutment face
- Bridge is on a skew and abutment ties are bearing on steel girders on one side and the extended abutment backwall on the other side

Concrete Spalling beneath Bearings

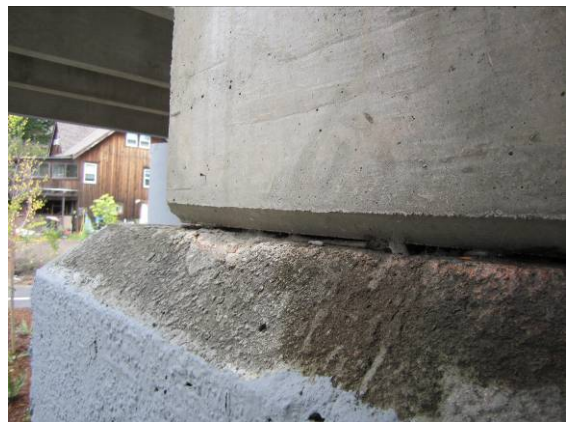
Gap between N. Abut. Seat and CIP Bearing Pad

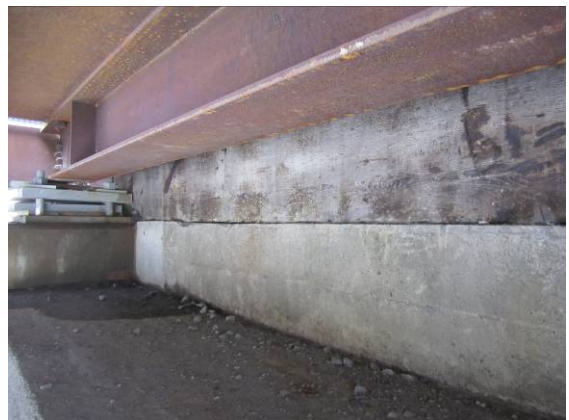
Timber Backwall at North Abutment

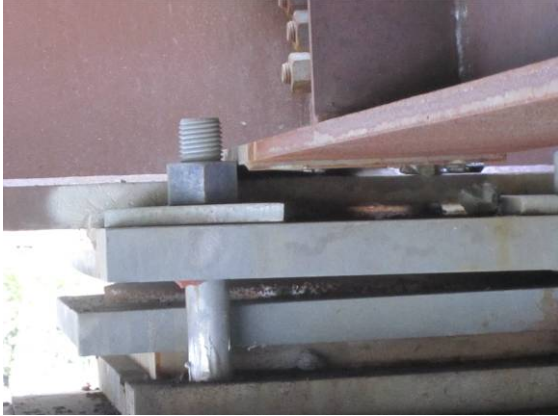
N. Abut. Anchor Bolt Touching End Floorbeam

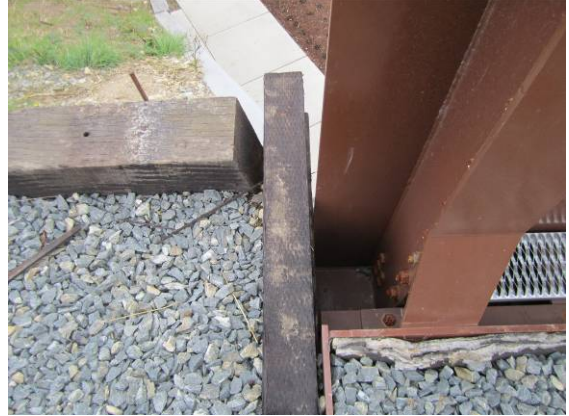
N. Timber Backwall Touching End of Girder

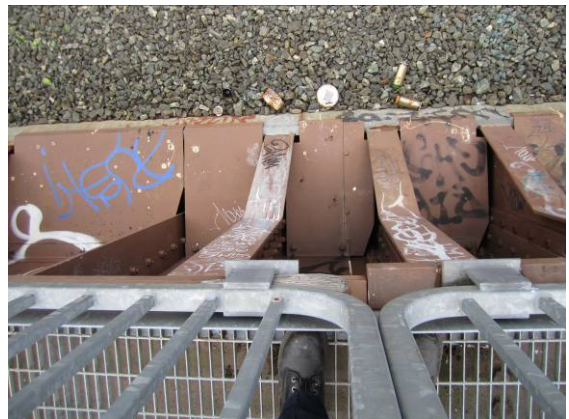
Top Flanges Touching at Pier 1

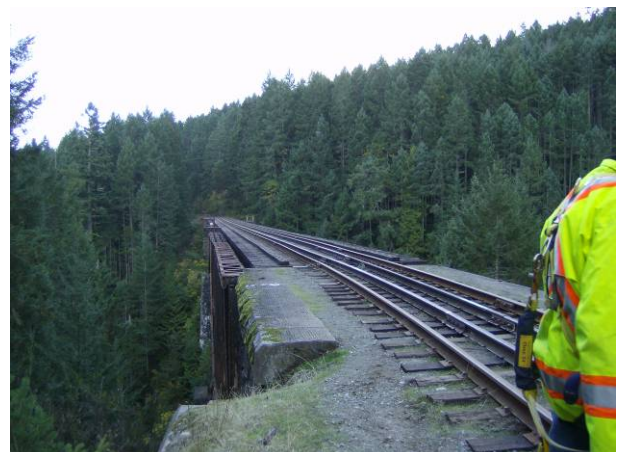
Masonry Pier (Typical)

- Cracks present in top of pier caps, near bearings (see attached photo)

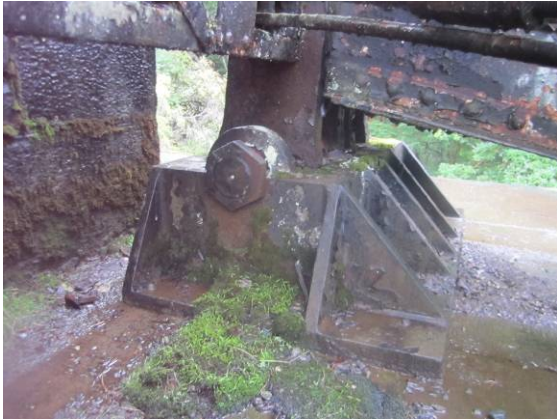
- Surface corrosion on both bearings
- Expansion bearings appear to allow rotation properly
- Bearing links at the abutments have a hole that is larger than the pin due to wear
- Enlarged hole in bearing link at abutment is allowing movement during loading
- Bearings on top of piers were not inspected at close proximity due to accessibility

Bearing at North Abutment

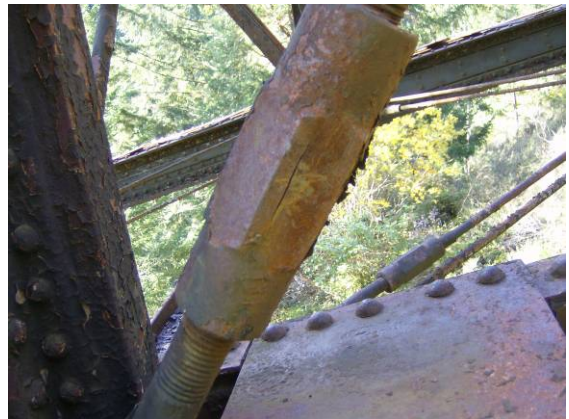
- Surface corrosion on all bracing members
- Loose diagonal bracing members are present in all spans
- Some minor section loss at cross frame locations
- Some bottom braces in cantilever span have rotated
- Cracked turnbuckle found in Span 3, Panel 3 of east exterior truss (see attached photo)

- Bearing links at the abutments have a hole that is larger than the pin and are allowing movement during loading
- Cracked turnbuckle found in Span 3, Panel 3 of east exterior truss (see attached photo)
- Two diagonals on the east truss were found to be loose at the top pin when shaken (U25-L24 & U26-L25)
- The majority of the bridge ties are poor
- Top hole in last hangar/post on north end (west side) has elongated approximately 1/16" and pin at this location has slackened by approximately 3/16"
- Pin LU7-Right and LU28-Left did not have acceptable NDT testing results

Cracked Turnbuckle in Span 3, Panel 3 (East)

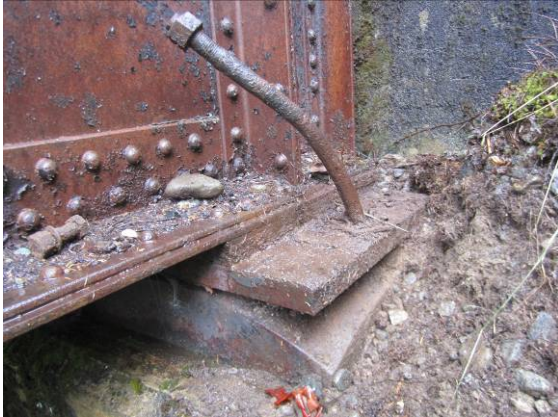
Anchor Bolt at South Abutment (West Girder)

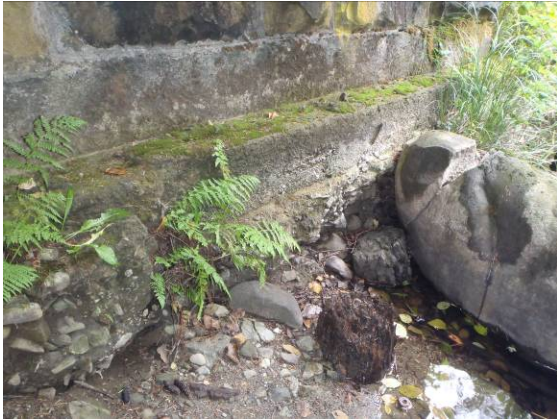
Abutment Undermining (Typical)

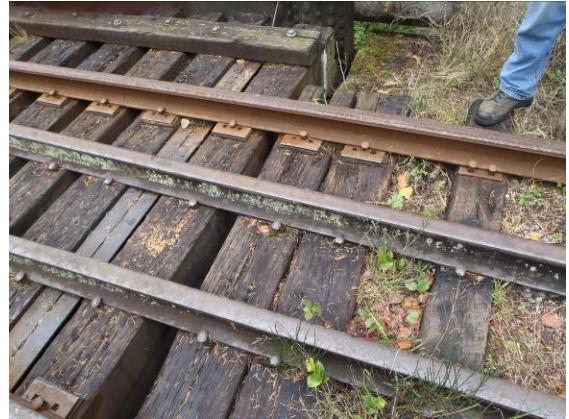
Swinging Approach Ties (North Abutment)

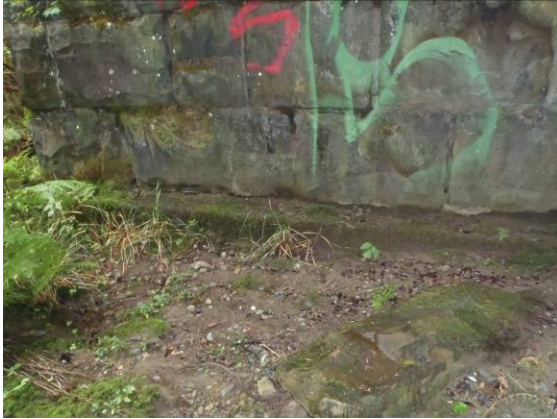
Base of South Abutment (Very Minor Scour)

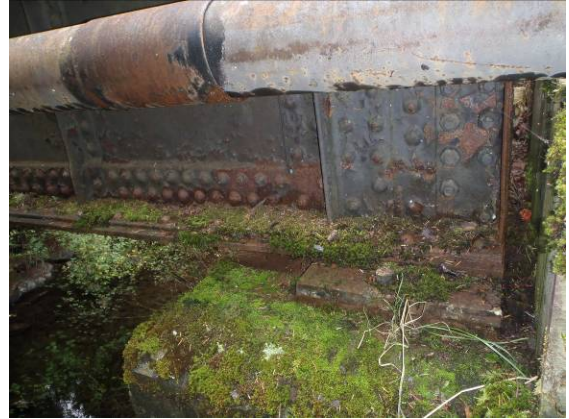
Moss on Abutment Seat (Typical)

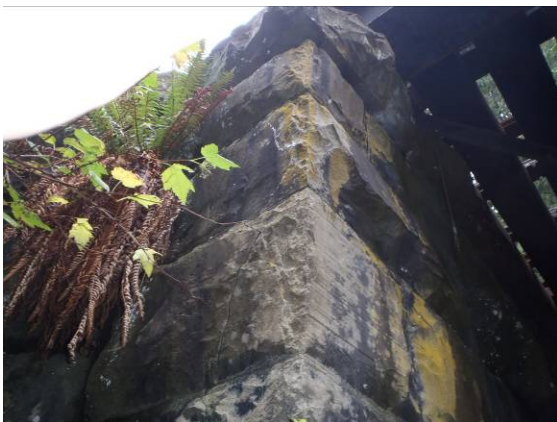
Crack in North Abutment (West End)

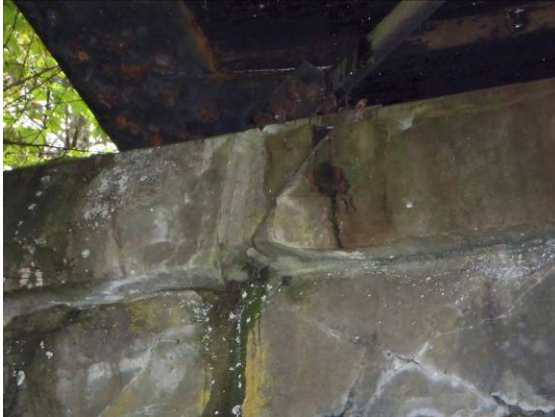
- No evidence of scour or undermining
- Ballast and/or drift accumulating on abutment seats
- Masonry blocks are cracking under bearings at both abutments (see attached photo)
- Several blocks in both abutments are fractured

Crack under South Abutment Bearing (East)

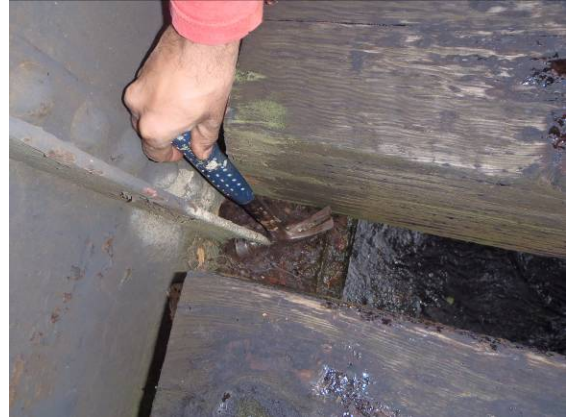
- Minor to moderate corrosion of steel girders
- Bottom angle section loss of 3 ½" x ¼" (vertical leg) and 2" x 1/8" (horizontal leg)
- Stiffeners have 100% section loss near bottom flange angles (see attached photo)

Section Loss at Bottom of Stiffener (Typical)

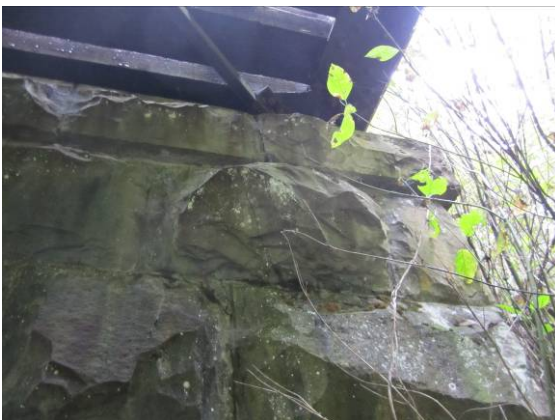
Crack under South Abutment Bearing (West)

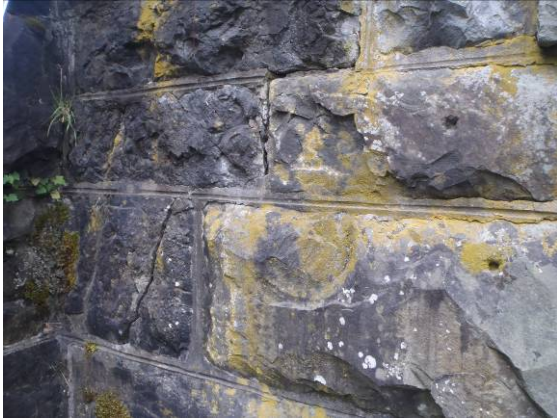
- Signs of collision damage from vehicles (non-structural)
- Cracks in masonry abutment blocks (see attached photo)

Crack in Masonry Abutment

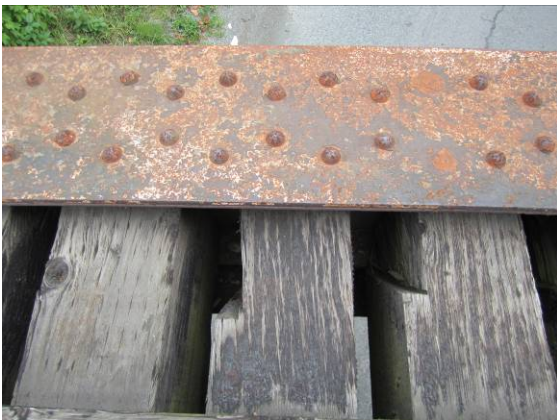
Notched Ties at Bearing Ends (Typical)

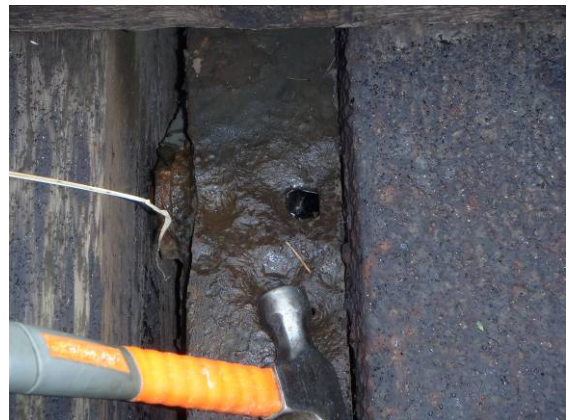
- Light to moderate corrosion throughout girders
- Bottom flange has been hit by vehicle
- Bottom lateral bracing system is heavily corroded with some holes through sections (see attached photo)

Corroded Bracing Members (Typical)

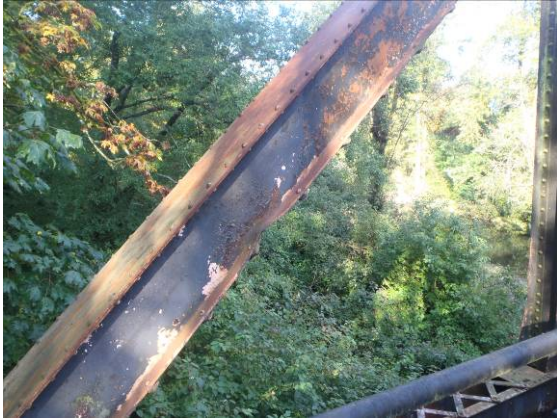
- Light to moderate corrosion on all primary steel members
- First diagonal truss member of west truss has impact damage to flange (see attached photo)

Impact Damage at South Diagonal (West Truss)

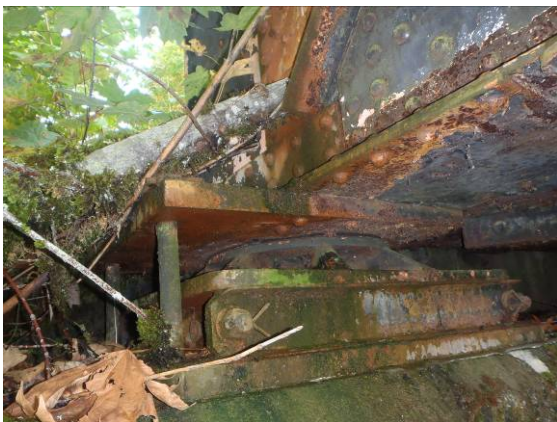
- Moderate to heavy corrosion on bearings; anchor bolts have moderate corrosion (see attached photo)

North Abutment Bearing (Typical)

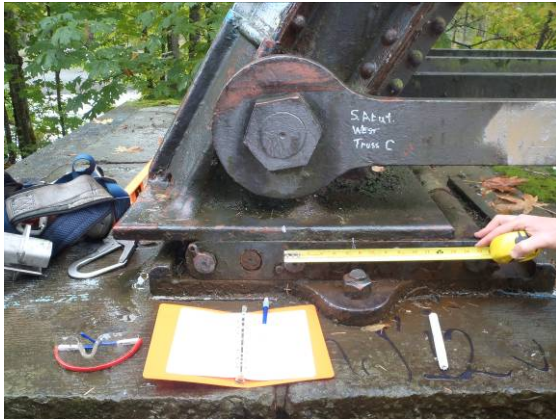
South Expansion Bearing (Rollers Exposed)

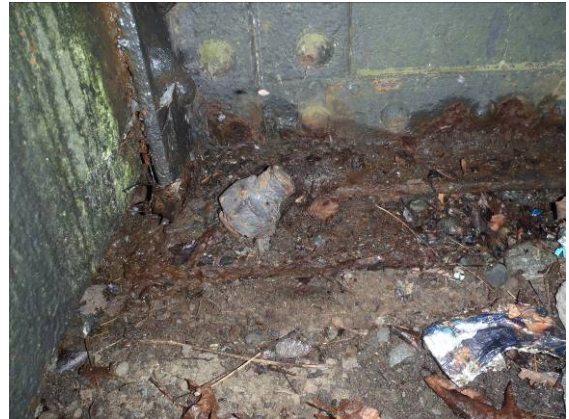
Bent Anchor Bolts at Stringer Bearing (Typical)

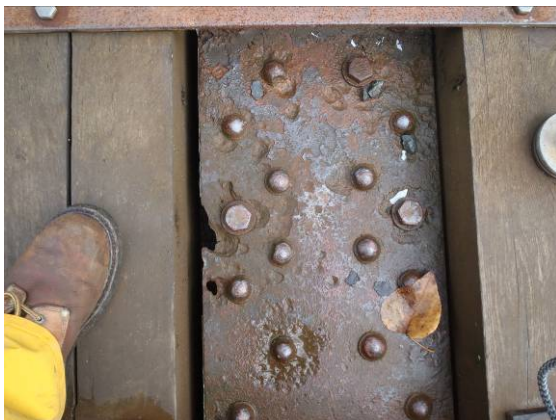
Floor Beam Top Flange (Typical Deterioration)

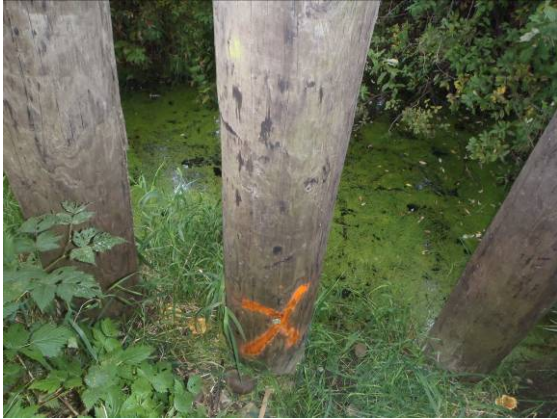
- Six round timber piles with a timber cap
- Two of the six piles at Bent 2 are exhibiting significant section loss due to rot
 - Bent 2, Pile 3 has severe core rot (see attached photo)
 - Bent 2, Pile 6 has rot; approximately 1 ½" sound to rot (see attached photo)

Rotten Pile at Bent 2 (Pile 3)

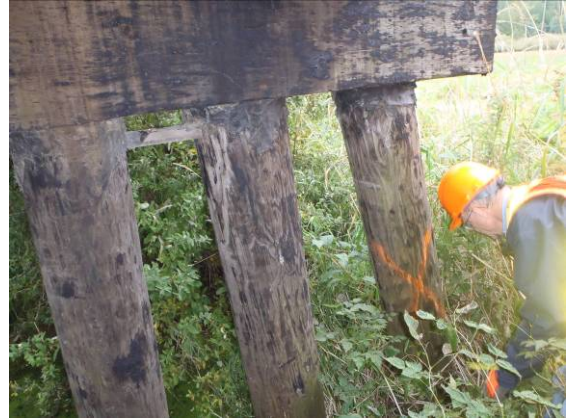
Rotten Pile at Bent 2 (Pile 6)

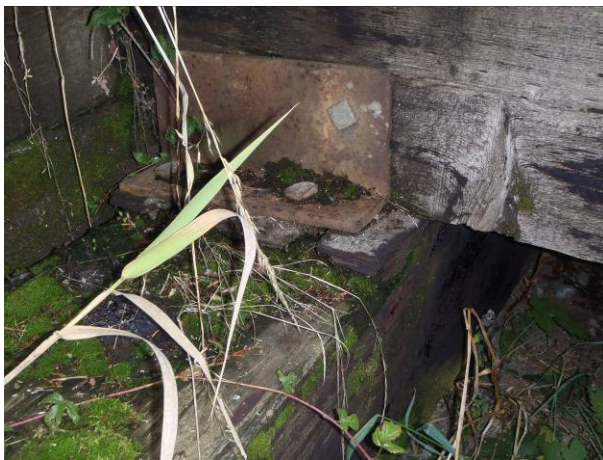
- Minor dirt and debris on bearings
- Minor vegetation on bearings
- Pile 2 of north end bent experiencing rot in core

North End Bent Bearing

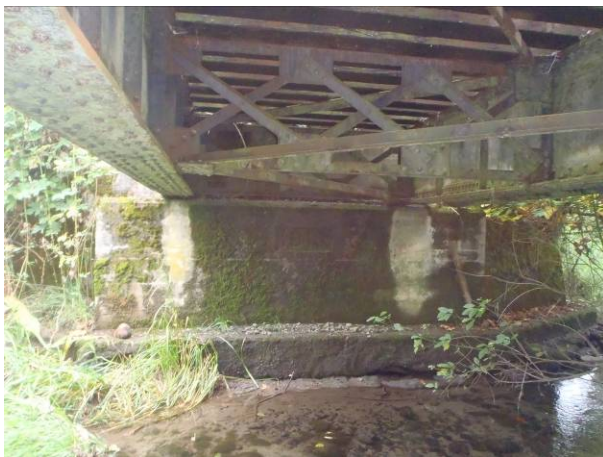
North Abutment View (Note Undermining)

- Creek appears to have begun undermining abutment footings (see attached photo)
- Debris and vegetation on abutments
- Minor spalling and cracks on face of abutments

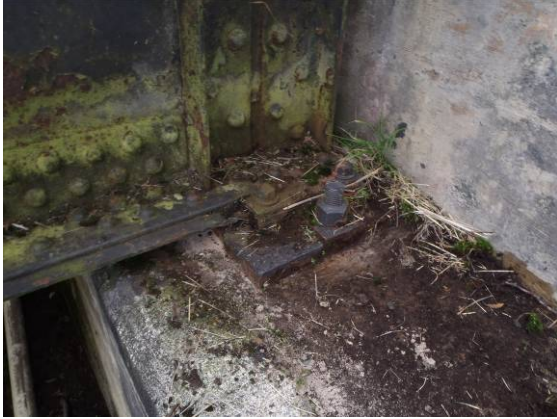
- Steel bearing plates
- Minor surface corrosion and moderate corrosion of anchor bolts
- Anchor bolt has been added to west bearing at south abutment

West Bearing at South Abutment (Note New Bolt)

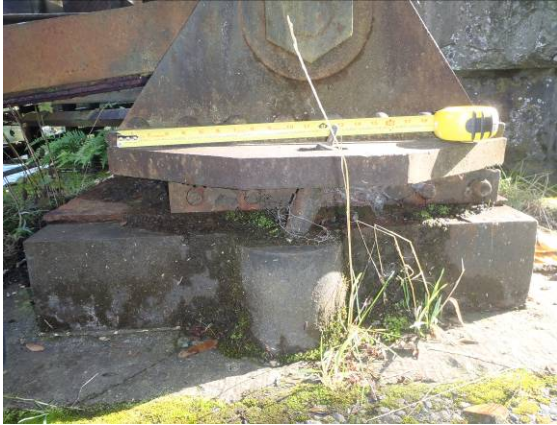
- Bearing rollers at south abutment are out of true alignment by approximately 2"
- Anchor bolt is bent 1 ½" towards abutments at south abutment west bearing (see attached photo)
- Mild corrosion on all bearings

Bent Anchor Bolt (South Abutment, West Bearing)

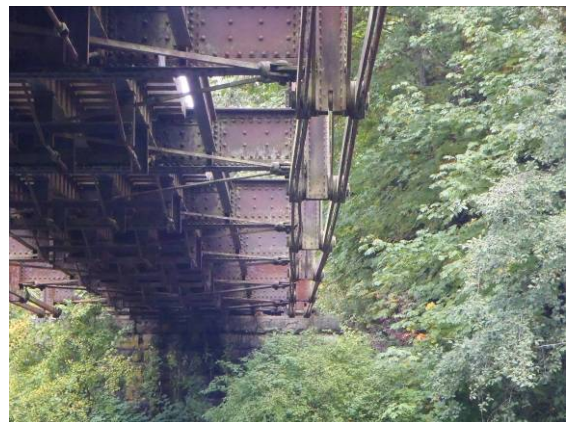
- Hangers have been tack welded
- Several diagonal members have a welded detail at the eye bar that could be fatigue-prone
- Moderate corrosion on all steel members
- Eyebars bent at 4th bay of west truss (see attached photo)
 - Likely a non-structural issue; probably caused by erection or maintenance activities

Bottom Eyebar Chords (Note Bent Bar)

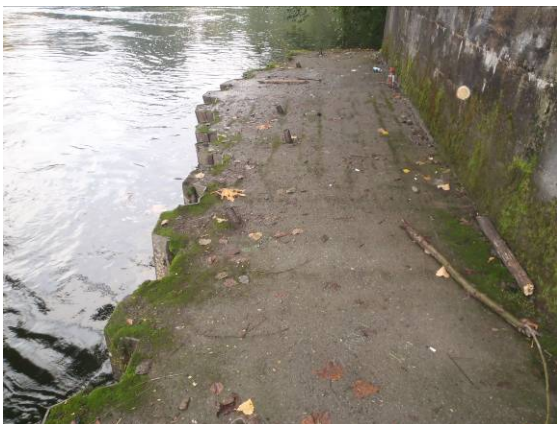
- Masonry abutment with concrete facing
- Light brush present on and around bearings
- Minor cracks on face of concrete
- Cofferdam located in front of abutment is in good condition (see attached photo)

Cofferdam in front of South Abutment

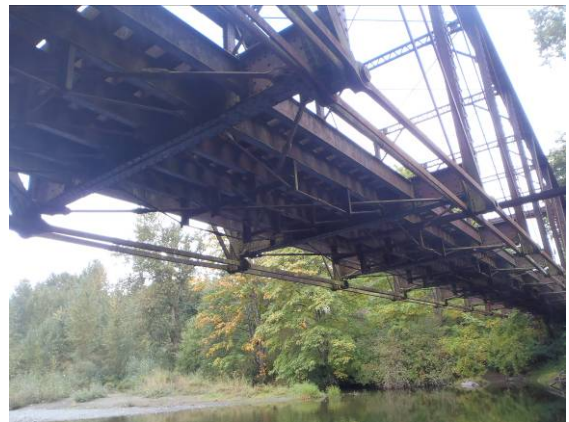
- Floor beams have been tack welded
- Steel strengthening detail (Queen posts) at floor beams does not appear to be functioning
 - Three of four rods are not tight at southernmost bay
 - This appears to be a typical condition throughout the bridge
 - Do not consider this strengthening when rating the bridge
 - Pin is missing from one of these strengthening rods
- Several loose rivets were found at the floor beam to stringer connections (located at Point 2)
 - At one location, three of the four rivets were loose
 - Only two bays at south end of bridge were inspected at close proximity
 - No proximity visual inspection of other bays due access

Underside of Bridge (Note Strengthening Detail)

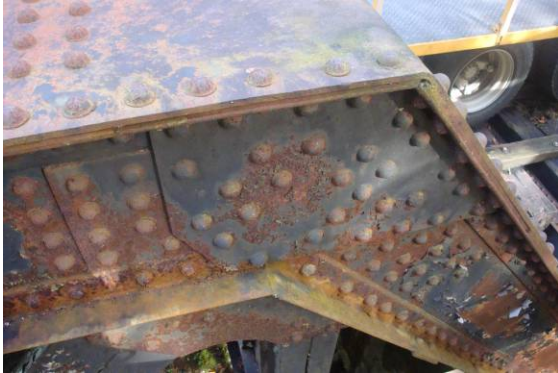
Steel Corrosion (Typical)

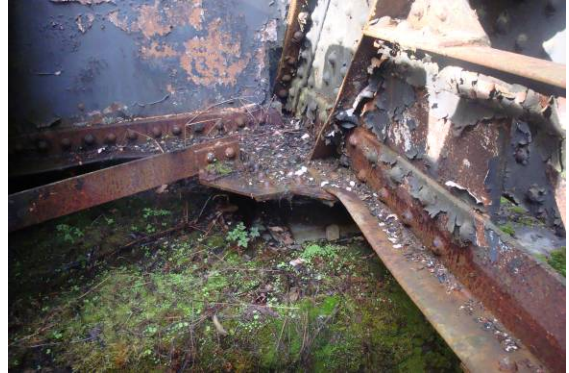
Bent Bottom Flange at Bearing (Typical)

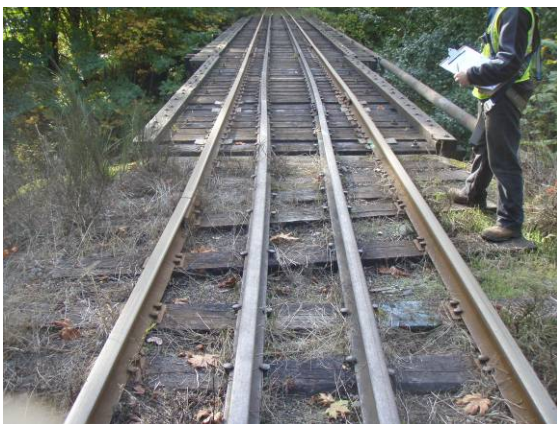
Swinging Ties at North Approach

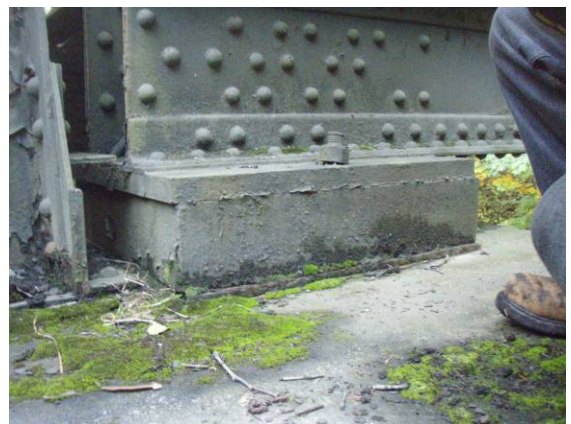
Bent Anchor Bolt at NW Bearing of Span 1

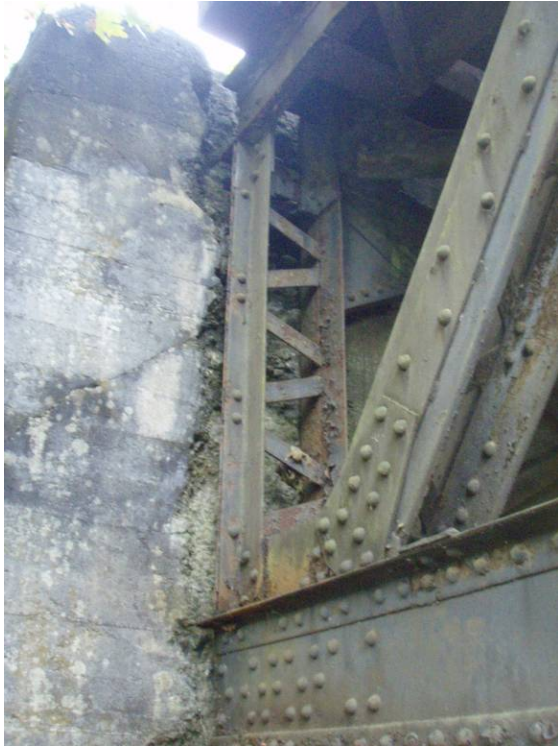
South Backwall (Chipped Out for Truss)

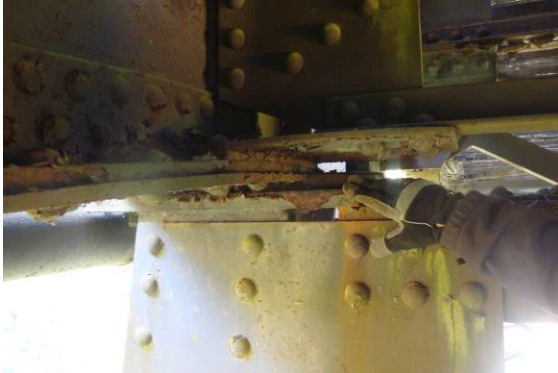
Bottom Flange Section Loss (Span 1, Pier 1)

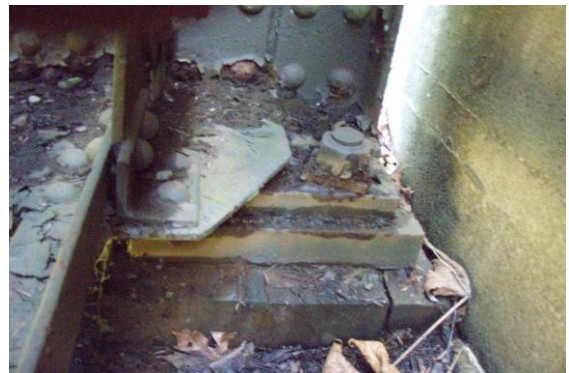
Split Timber Bearing Block (South Abutment)

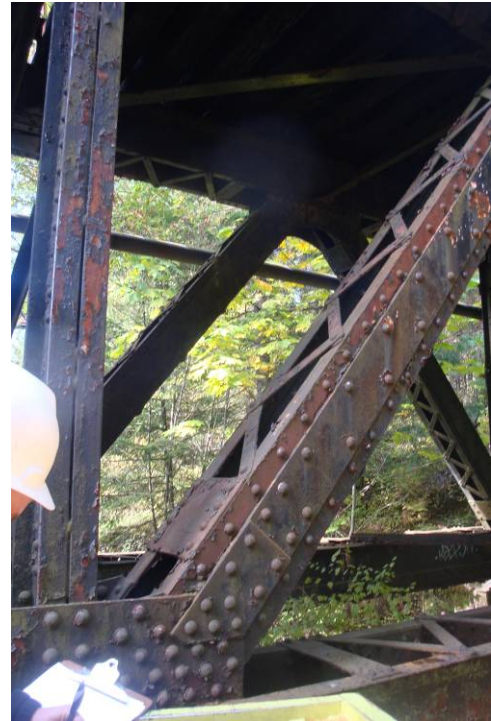
Strengthened Diagonal Truss Member

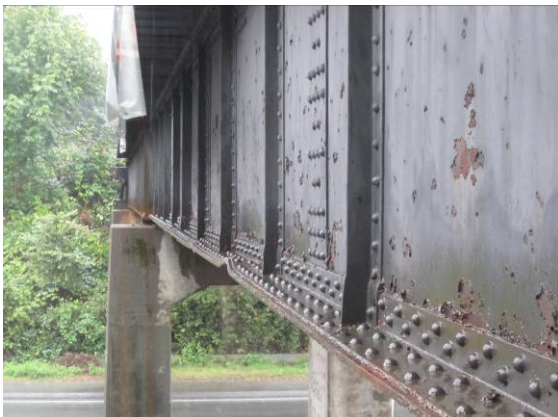
- Bottom flange of Span 4 was severely hit by vehicle; further investigation required (see attached photo)

Impact Damage at Span 4 Bottom Flange

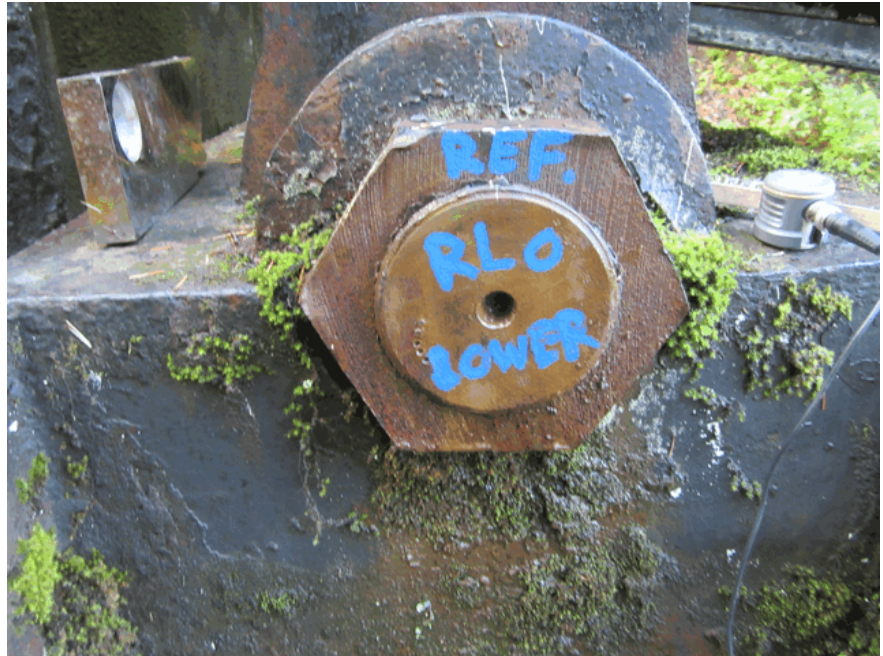
Photo 2:

Clean signal (100% Full Screen Height) achieved at 70 DB, used as a reference when inspecting the other pins.

Instrument settings were optimized for best performance. Although a 2.25MHz probe was used the frequency of the instrument was set to 1.00MHz and the filter was adjusted to correspond with the actual frequency of the transducer.

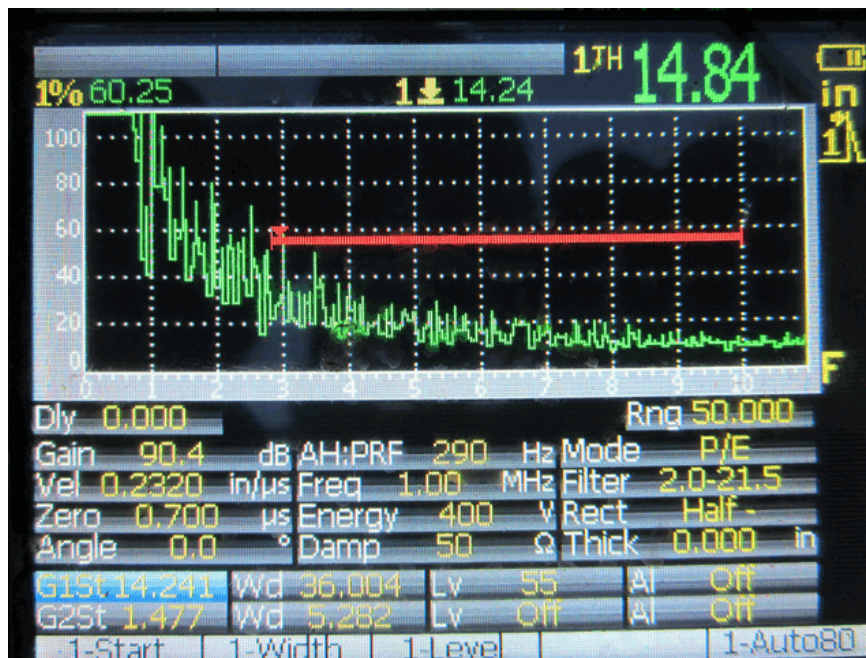
Photo 8:

Overview of the double pin configuration at LU28.

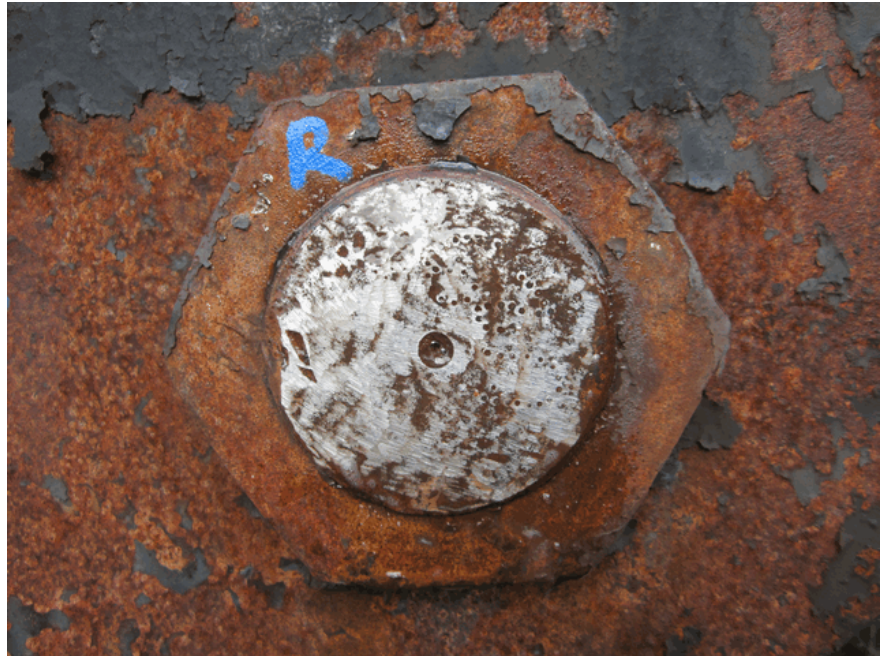
Photo 10:

Screen shot of the right pin at LU28.
80% back wall achieved at 79.4 DB.

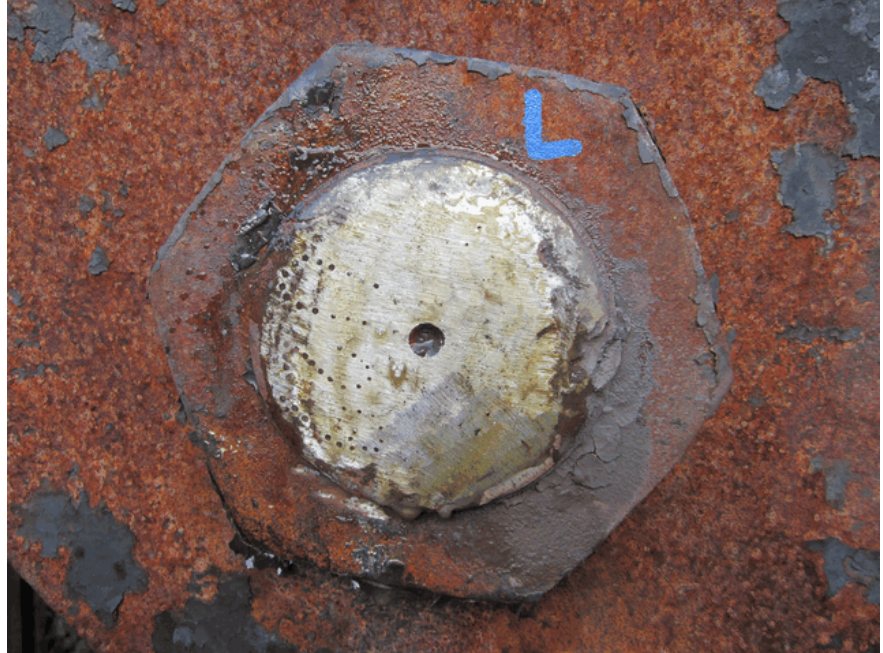
Photo 12:

Screen shot of ultrasonic test done at LU28-Left Pin. Note the amplitude of 82.2 and zero back wall showing. (Amplitude was increased further but no back wall was seen). This was the result regardless of where the probe was positioned on the outside surface of the pin.

No access to the backside of the pin at this location. There is a space of approximately ½" between the pin and the bridge stringer.

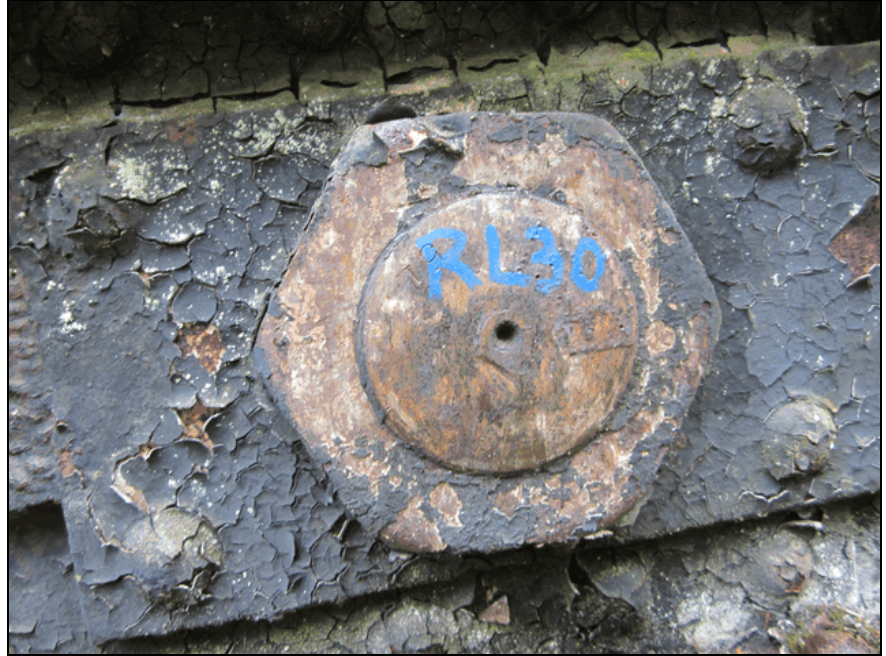
Photo 14:

A typical pin showing back wall reflectors at Full Screen Height when scanning at 76DB (+6DB above reference).

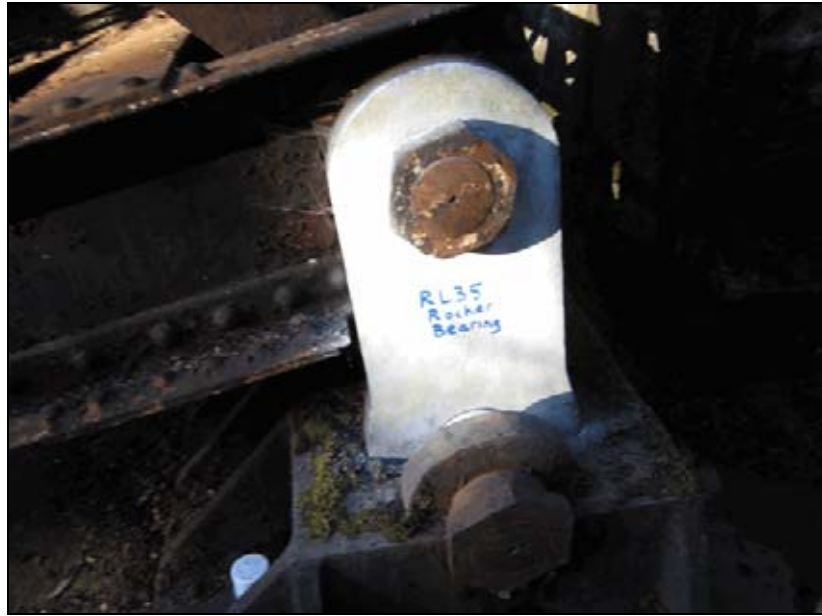
Photo 1:

Overview of the rocker bearing tested on the Right Lower side at pin 35. MT OK.

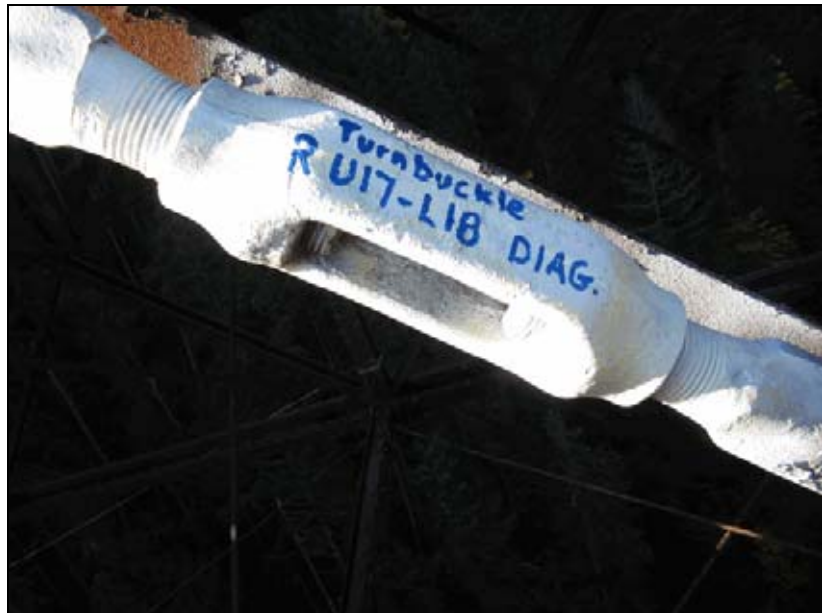
Photo 2:

Overview of a typical turnbuckle tested. This one (1) on the Right side Upper 17 to Lower 18 diagonal support. MT OK.

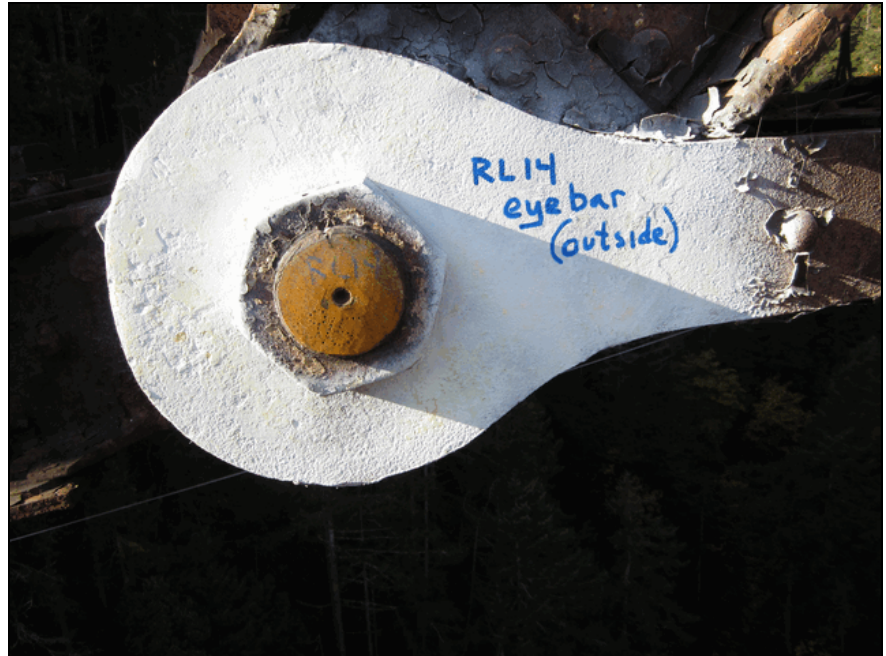
Photo 3:

Overview of a typical Eyebar end tested. This one (1) on the Right Lower side at Pin 14 on the outside of the bridge. MT OK.

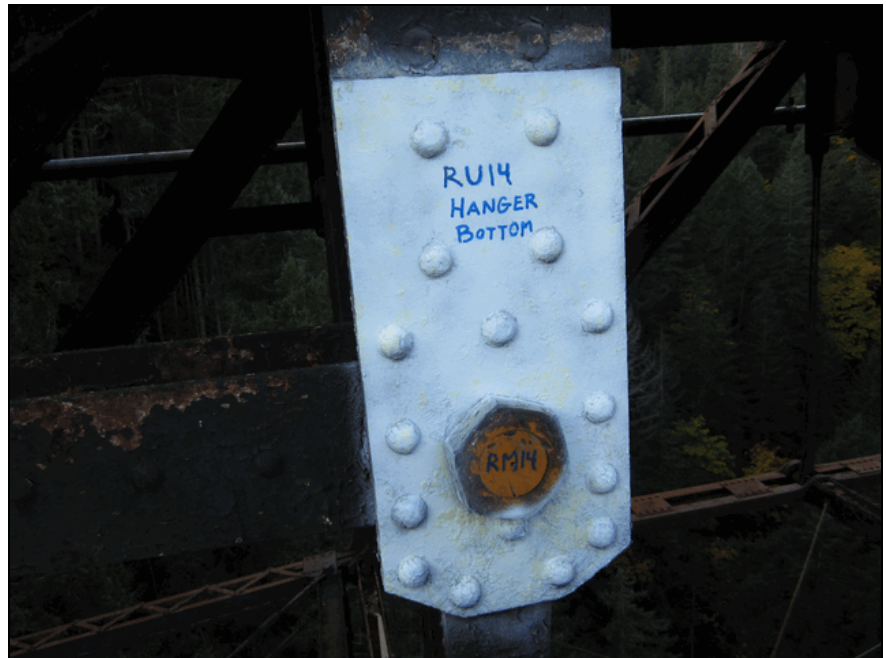
Photo 4:

Overview of the bottom Hanger tested on the Right upper side at Middle Pin 14. MT OK.

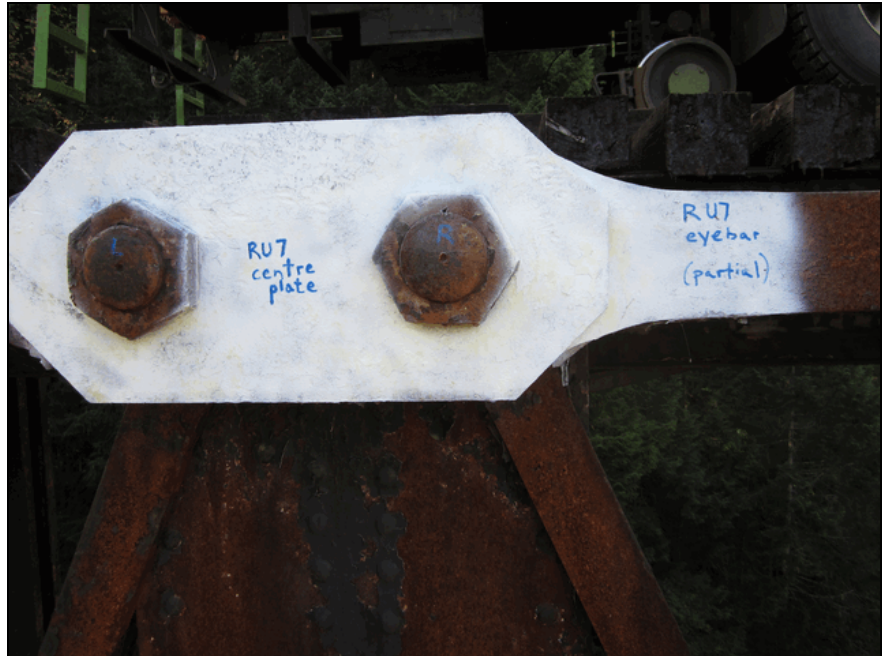
Photo 5:

Overview of a partial eyebar tested including the centre plate at Right Upper 7. MT OK.

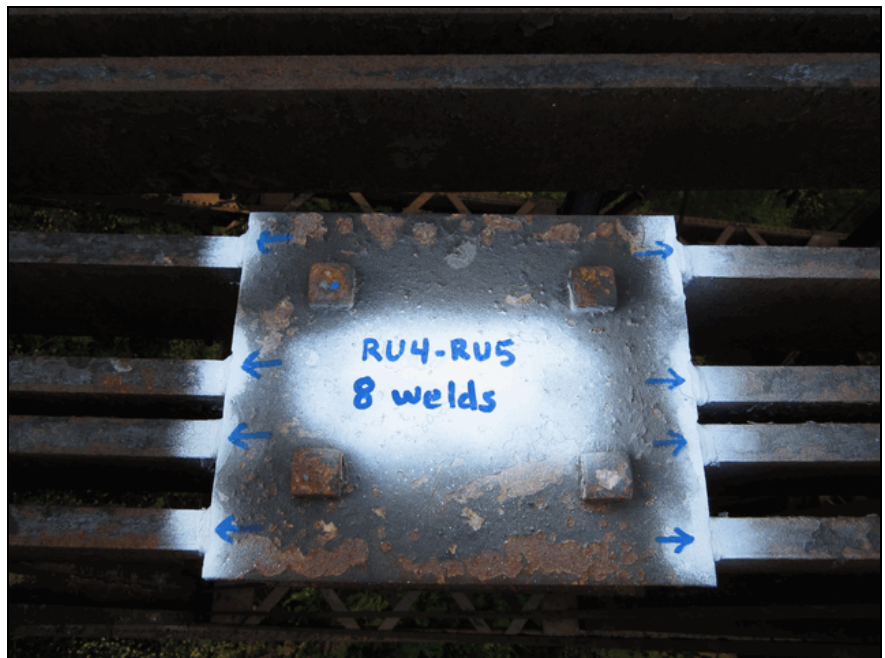
Photo 6:

Eight (8) welds tested on the reinforcement plate on upper chord Right Upper 4 to Right Upper 5.

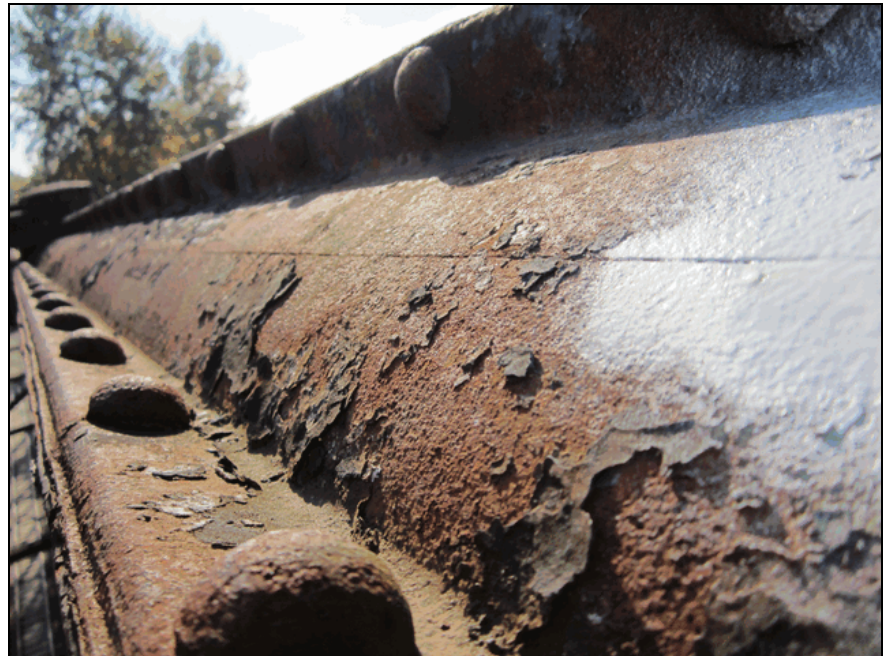
Photo 6:

Please note: Several inherent defects were noted throughout the bridge. Seam-like anomalies were noted running the length of four (4) of the upper chords. These "seams" run the entire length of upper chords and are very uniform in appearance. They were flagged as cracks on a previous visual inspection but after investigation and

magnetic particle testing it was determined that they are inherent defects from manufacturing. See photos for details (Photos 6-15).

Seam noted on top chord between Columns U9-U10. Seen elsewhere throughout bridge looking just as uniform.

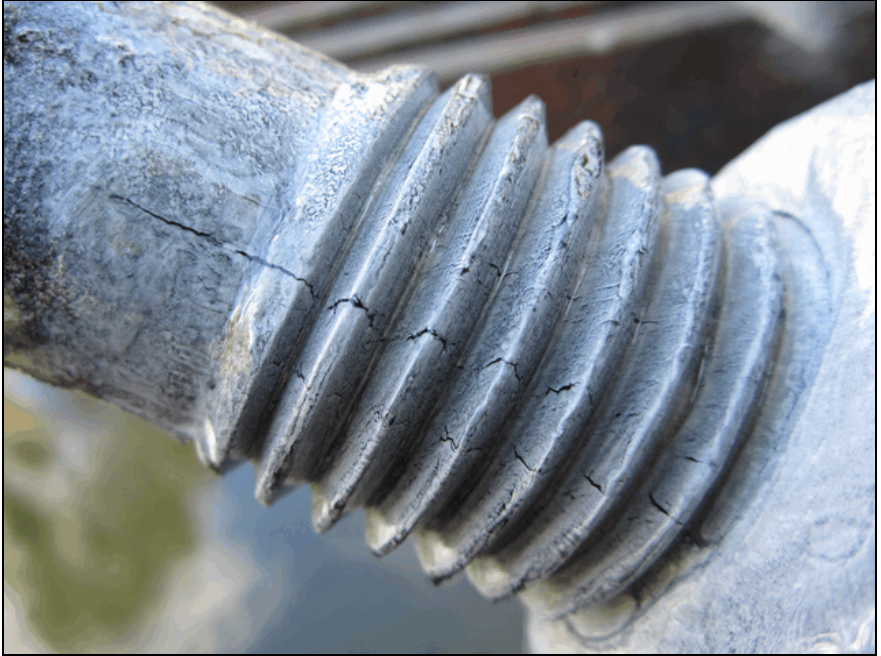
Photo 15:

Crack indications noted in the threads on DL4-Left side.

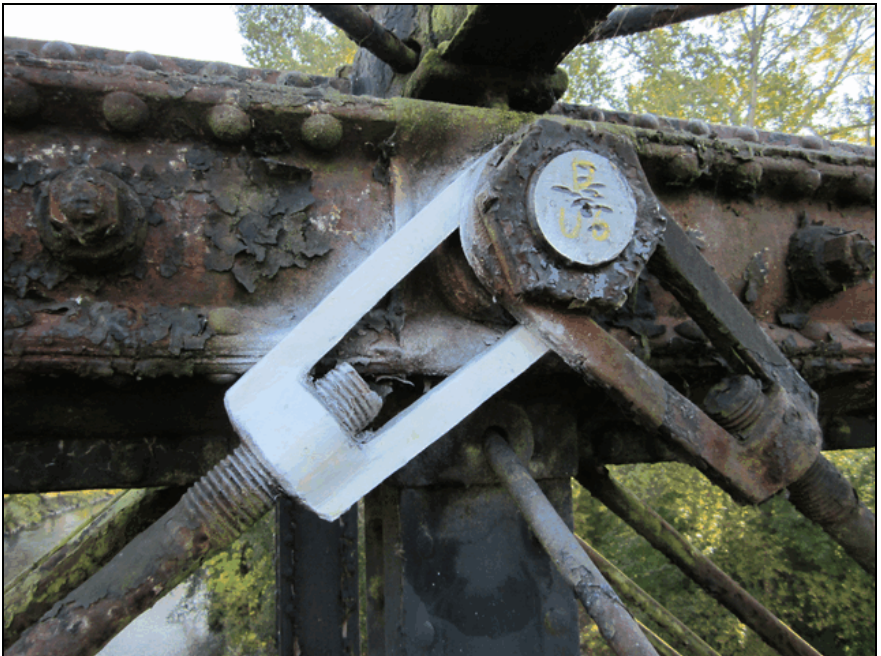
Photo 16:

Upper turnbuckle tested at D-U-6 (inside) - MT Ok.

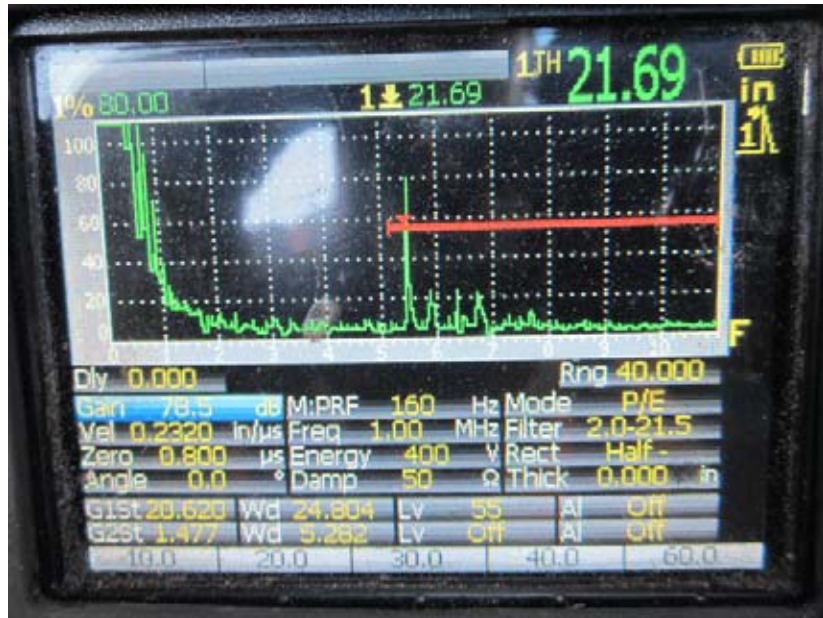
Photo 1:

Screen shot showing typical inspection results. This one from Left side Upper pin number 4.

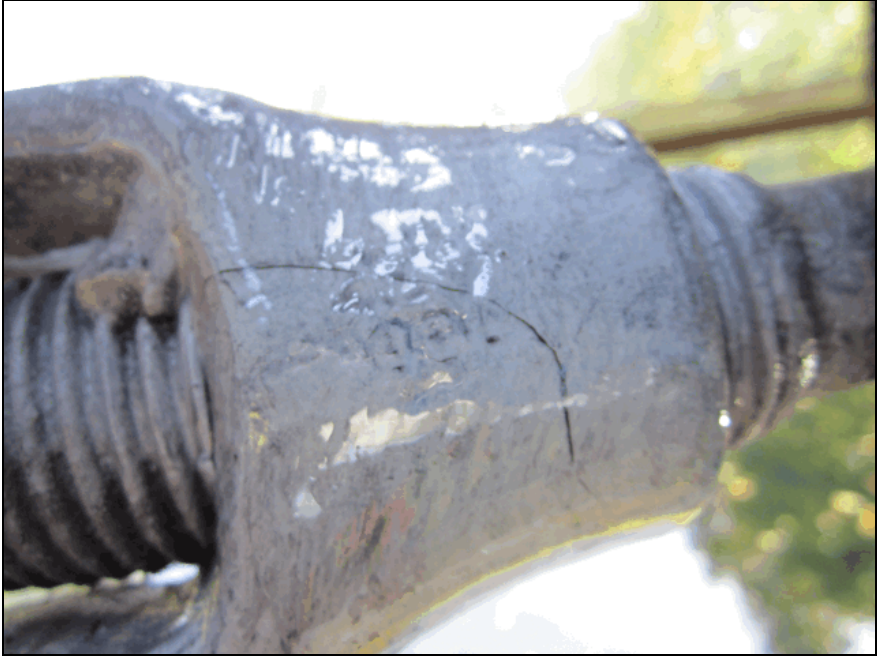
Photo 5:

Close up of 3" crack found on Turnbuckle Lower 3 to Lower 4 on Queen Post Truss #3.
