**Bridge Inspection and Assessment –
E&N Railway, Vancouver Island, BC Canada**

**Phase 1 - Inspection Report
Bridges from Mile 1.30 to Mile 65.10 and 2
Bridges on the Wellcox Spur (28 Bridges)**

February 15, 2012

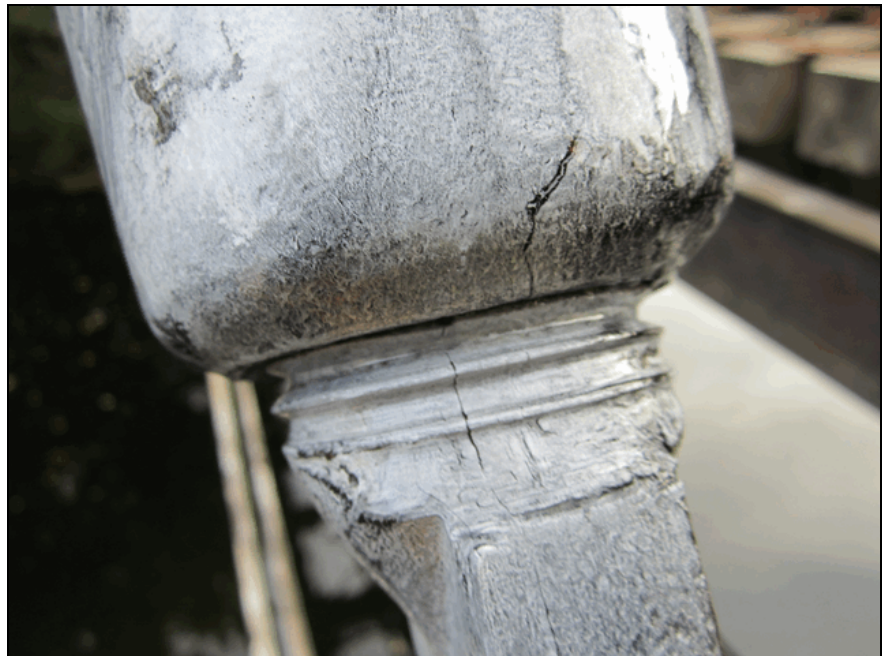
Photo 8:

Two (2) crack indications, approximately 1" each, noted in the lower portion of the turnbuckle and in the threads on the diagonal at Right Upper 4 to Lower 5.
